The September 2013 Flood: What We Saw, and What It Might Mean

Steven Griffin, PE, CFM
Region 4 Hydraulics Engineer

COLORADO
Department of
Transportation

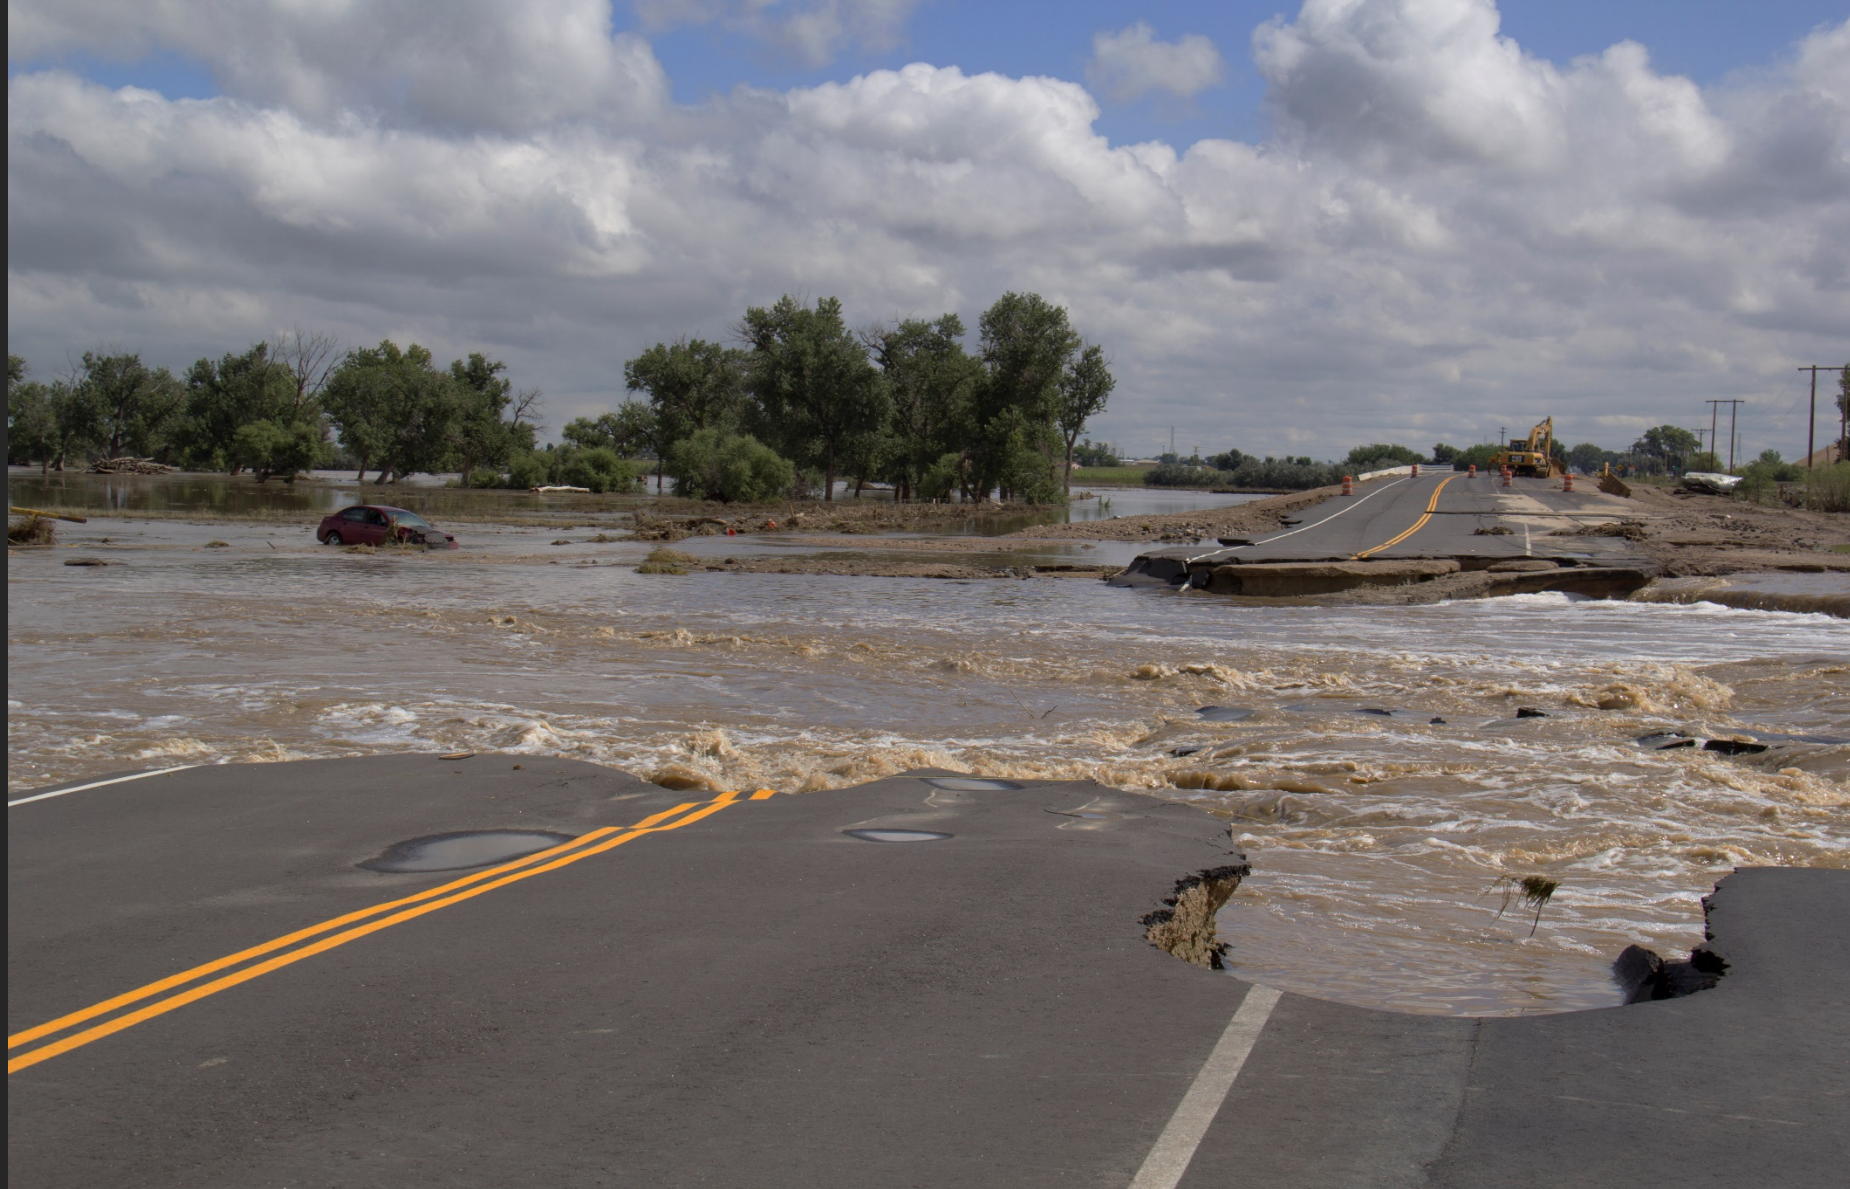
River Flows Ranged from 25 yr Recurrence up to ~500 yr Recurrence

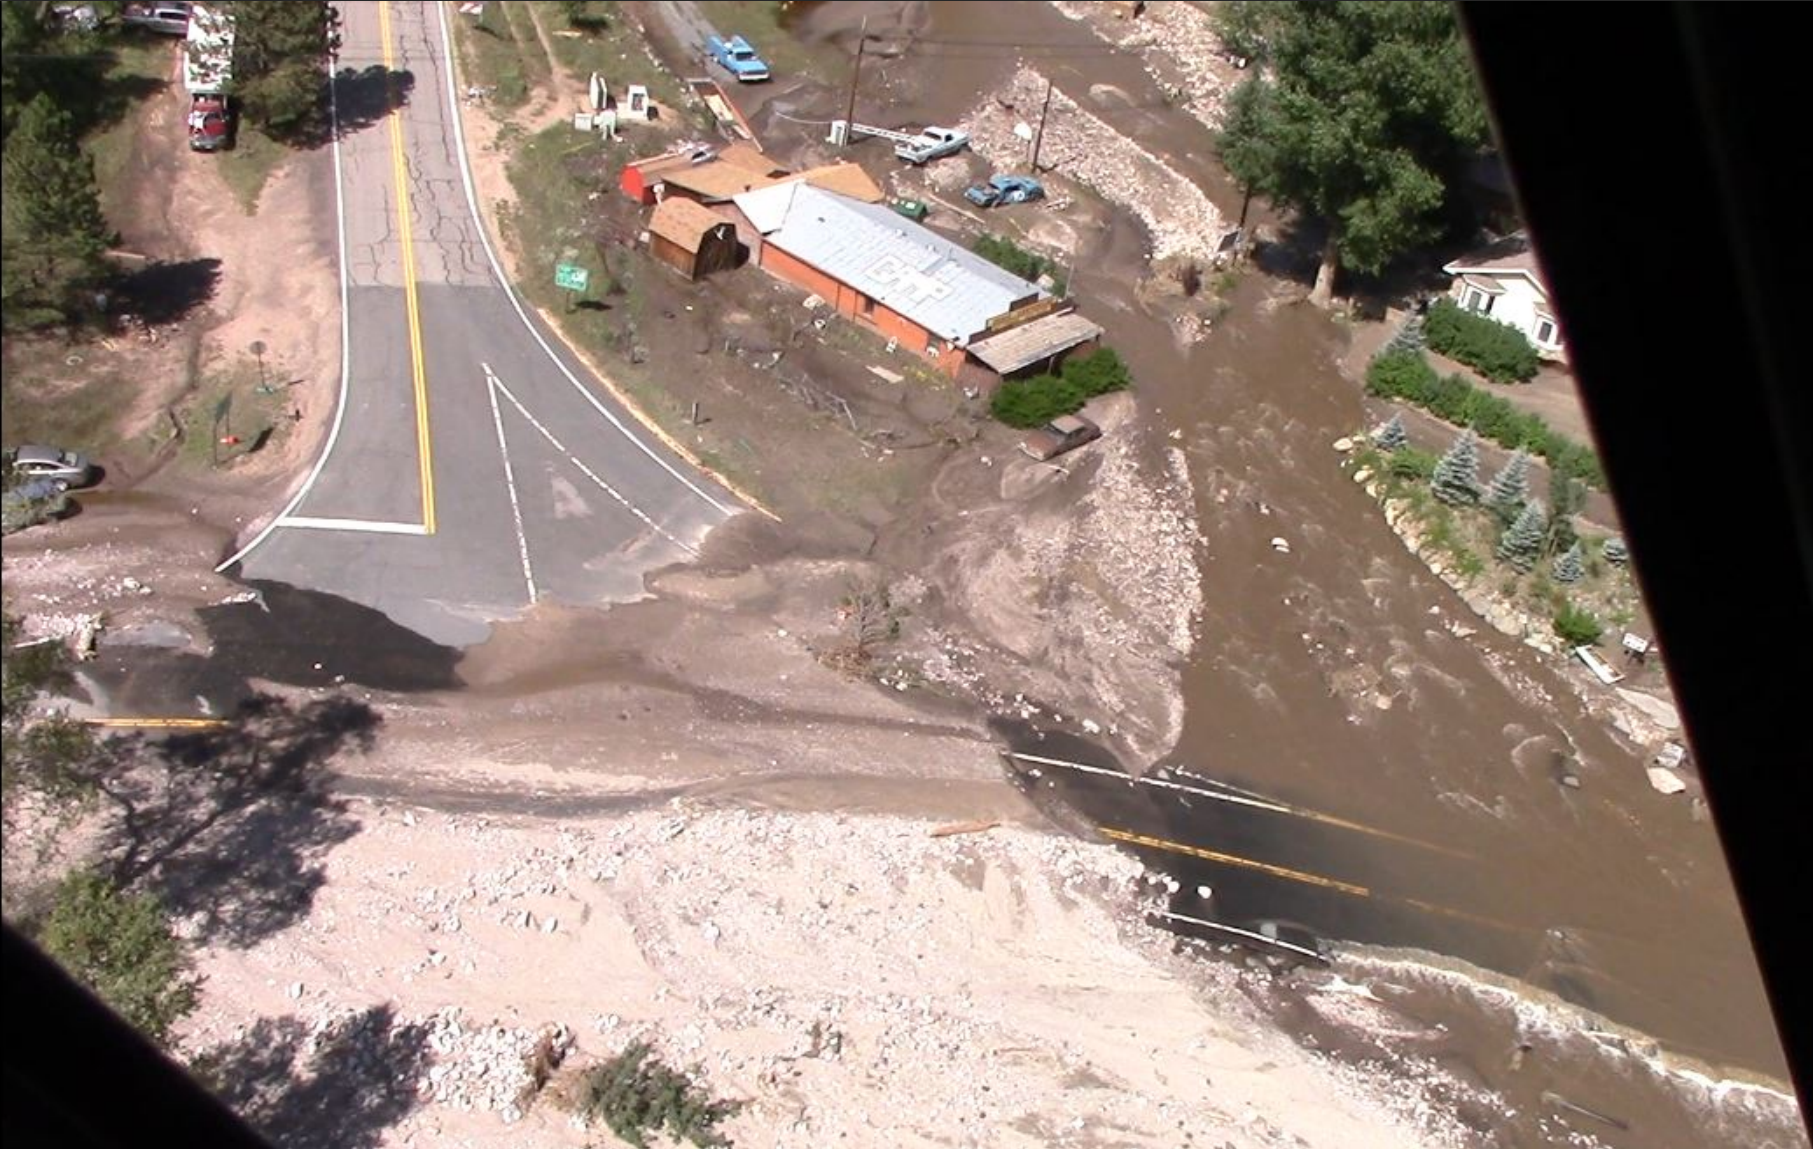
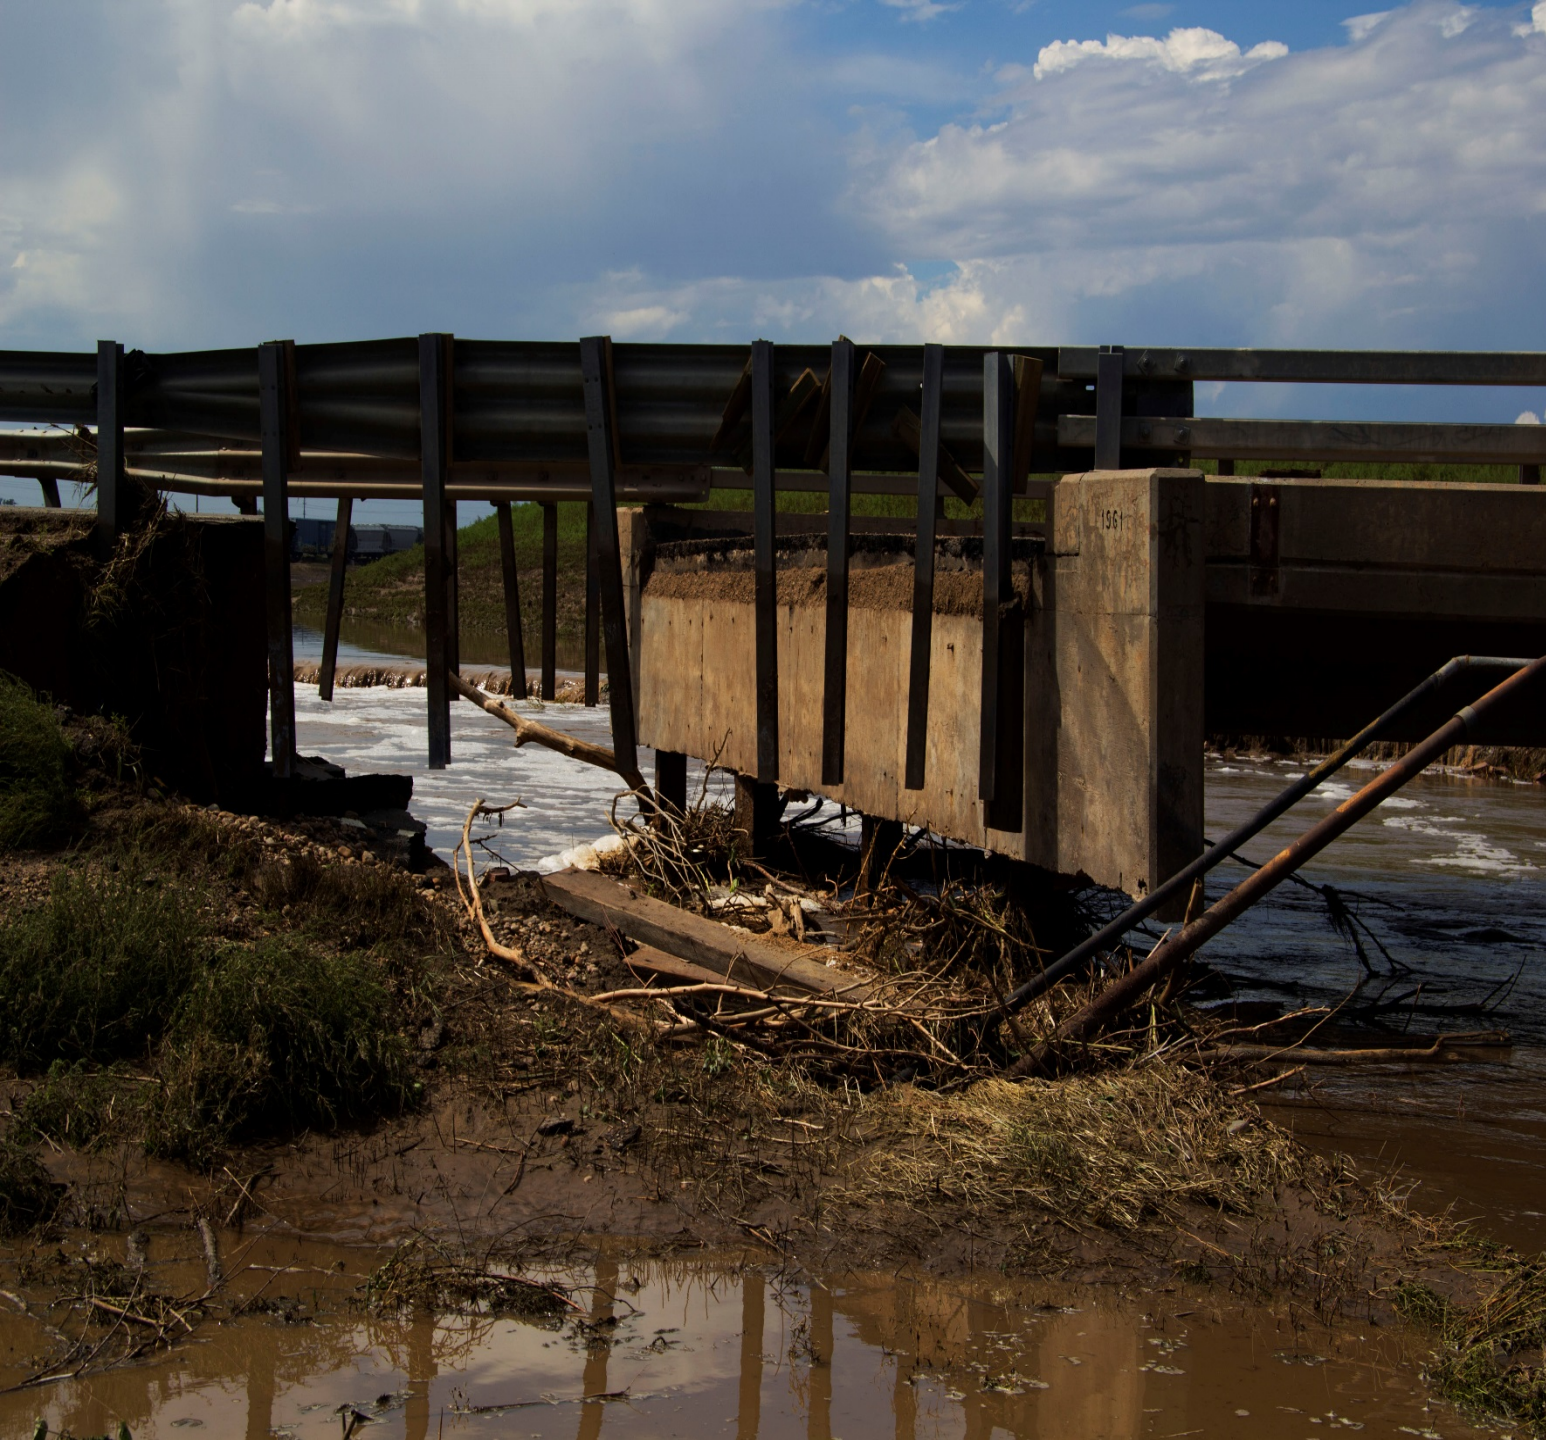
Roadway Overtopping and Saturated Embankments

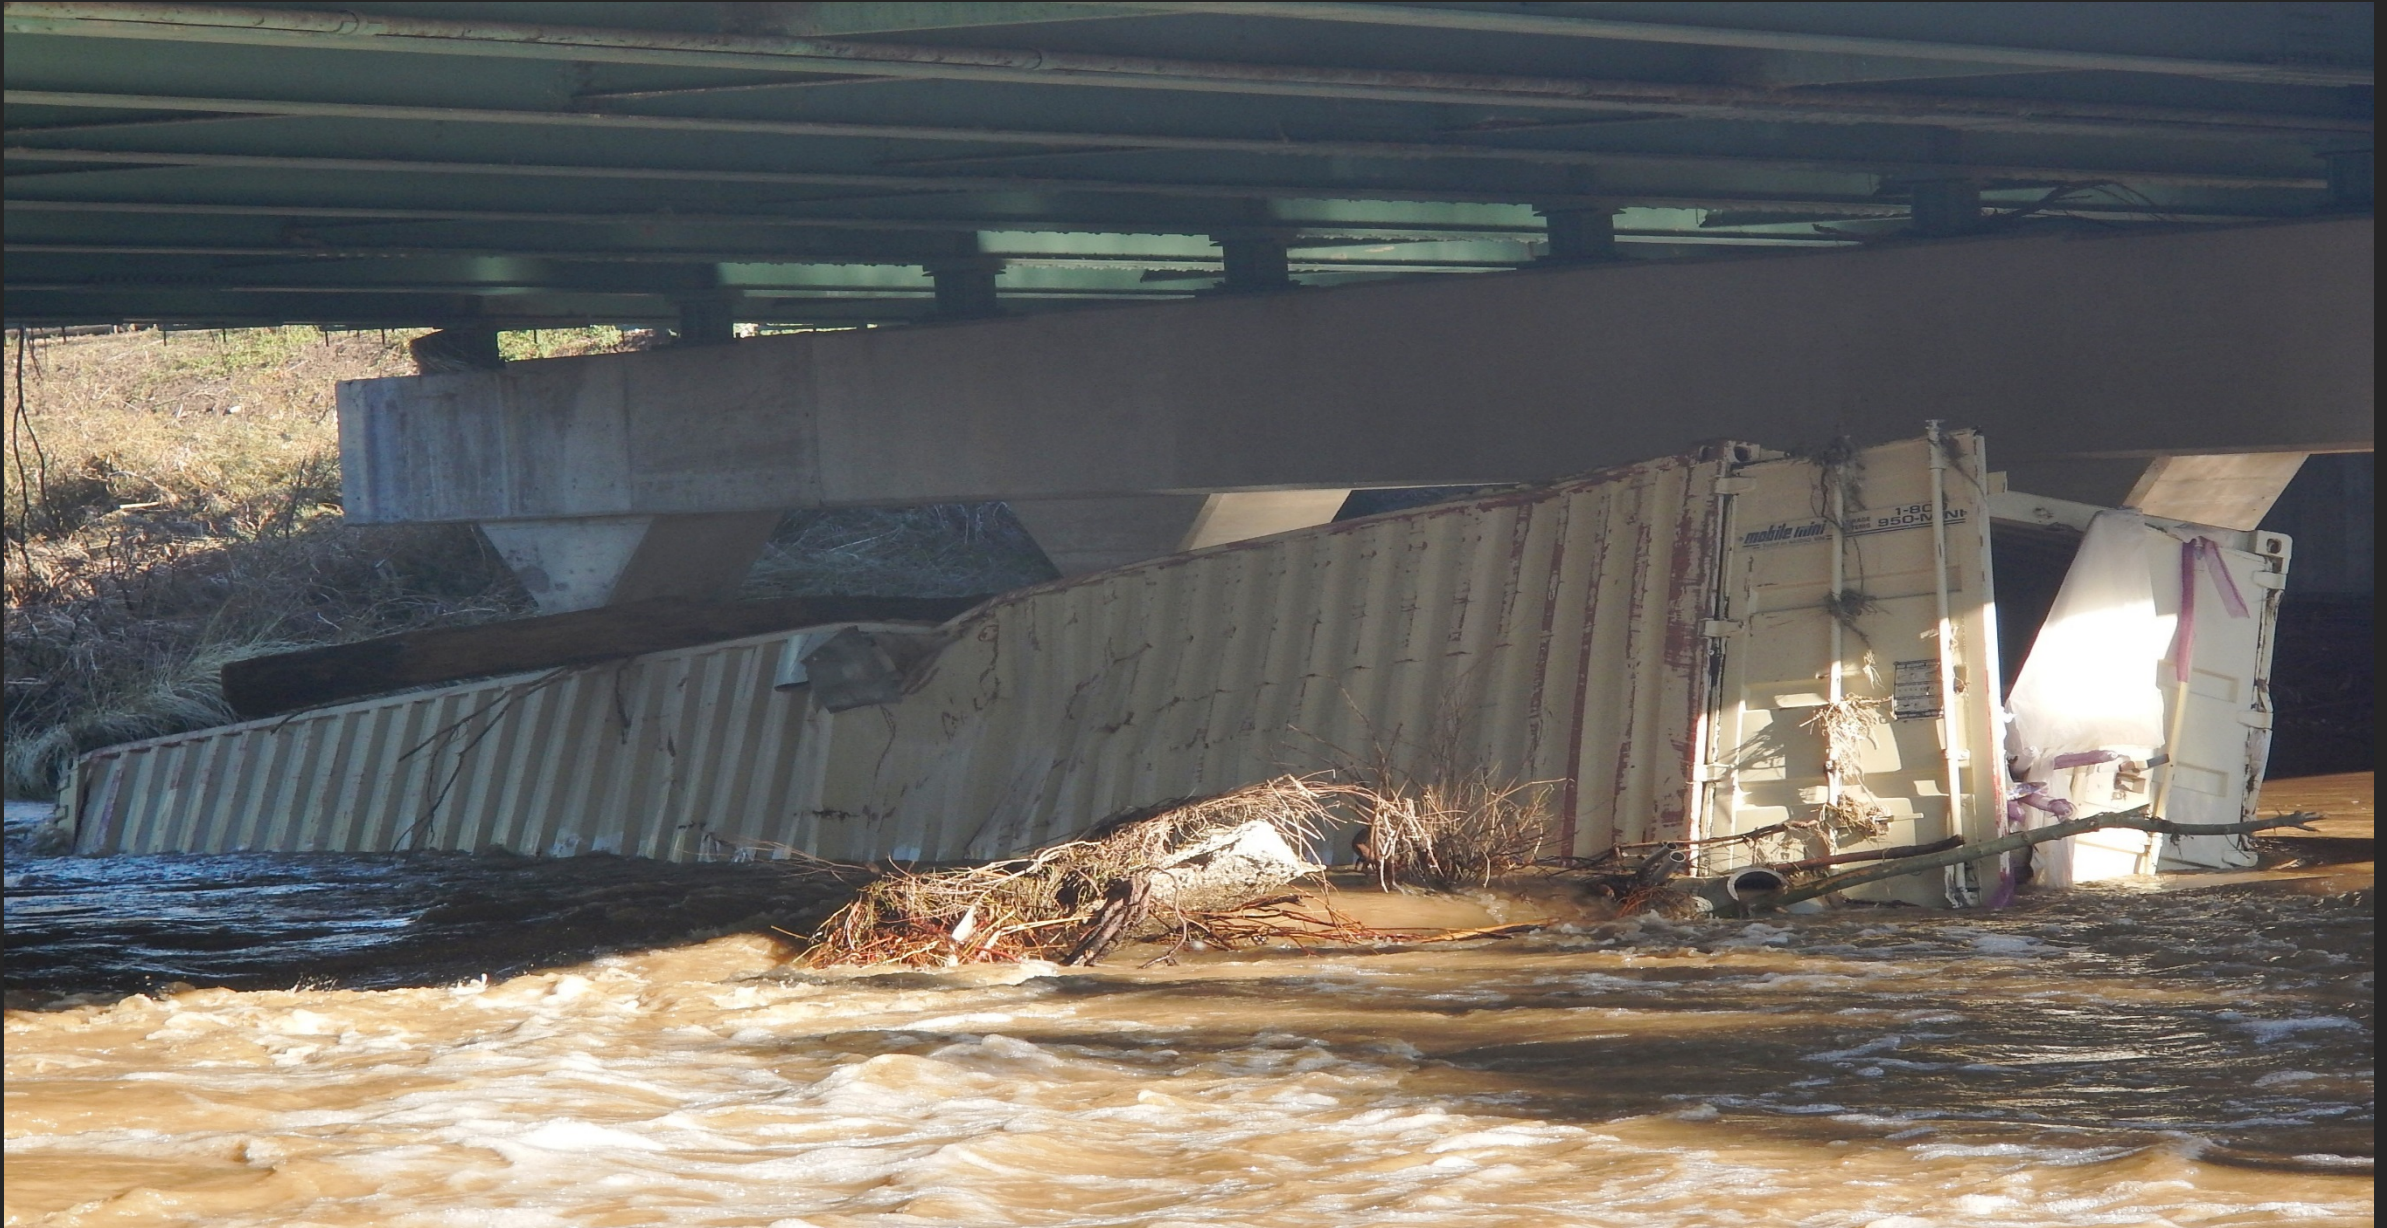
Washed Out
Bridge
Approaches on
Highway Bridges
(Smaller Bridges
are Undermined)

1. State and Federal highway bridges survived, though bridge approaches failed

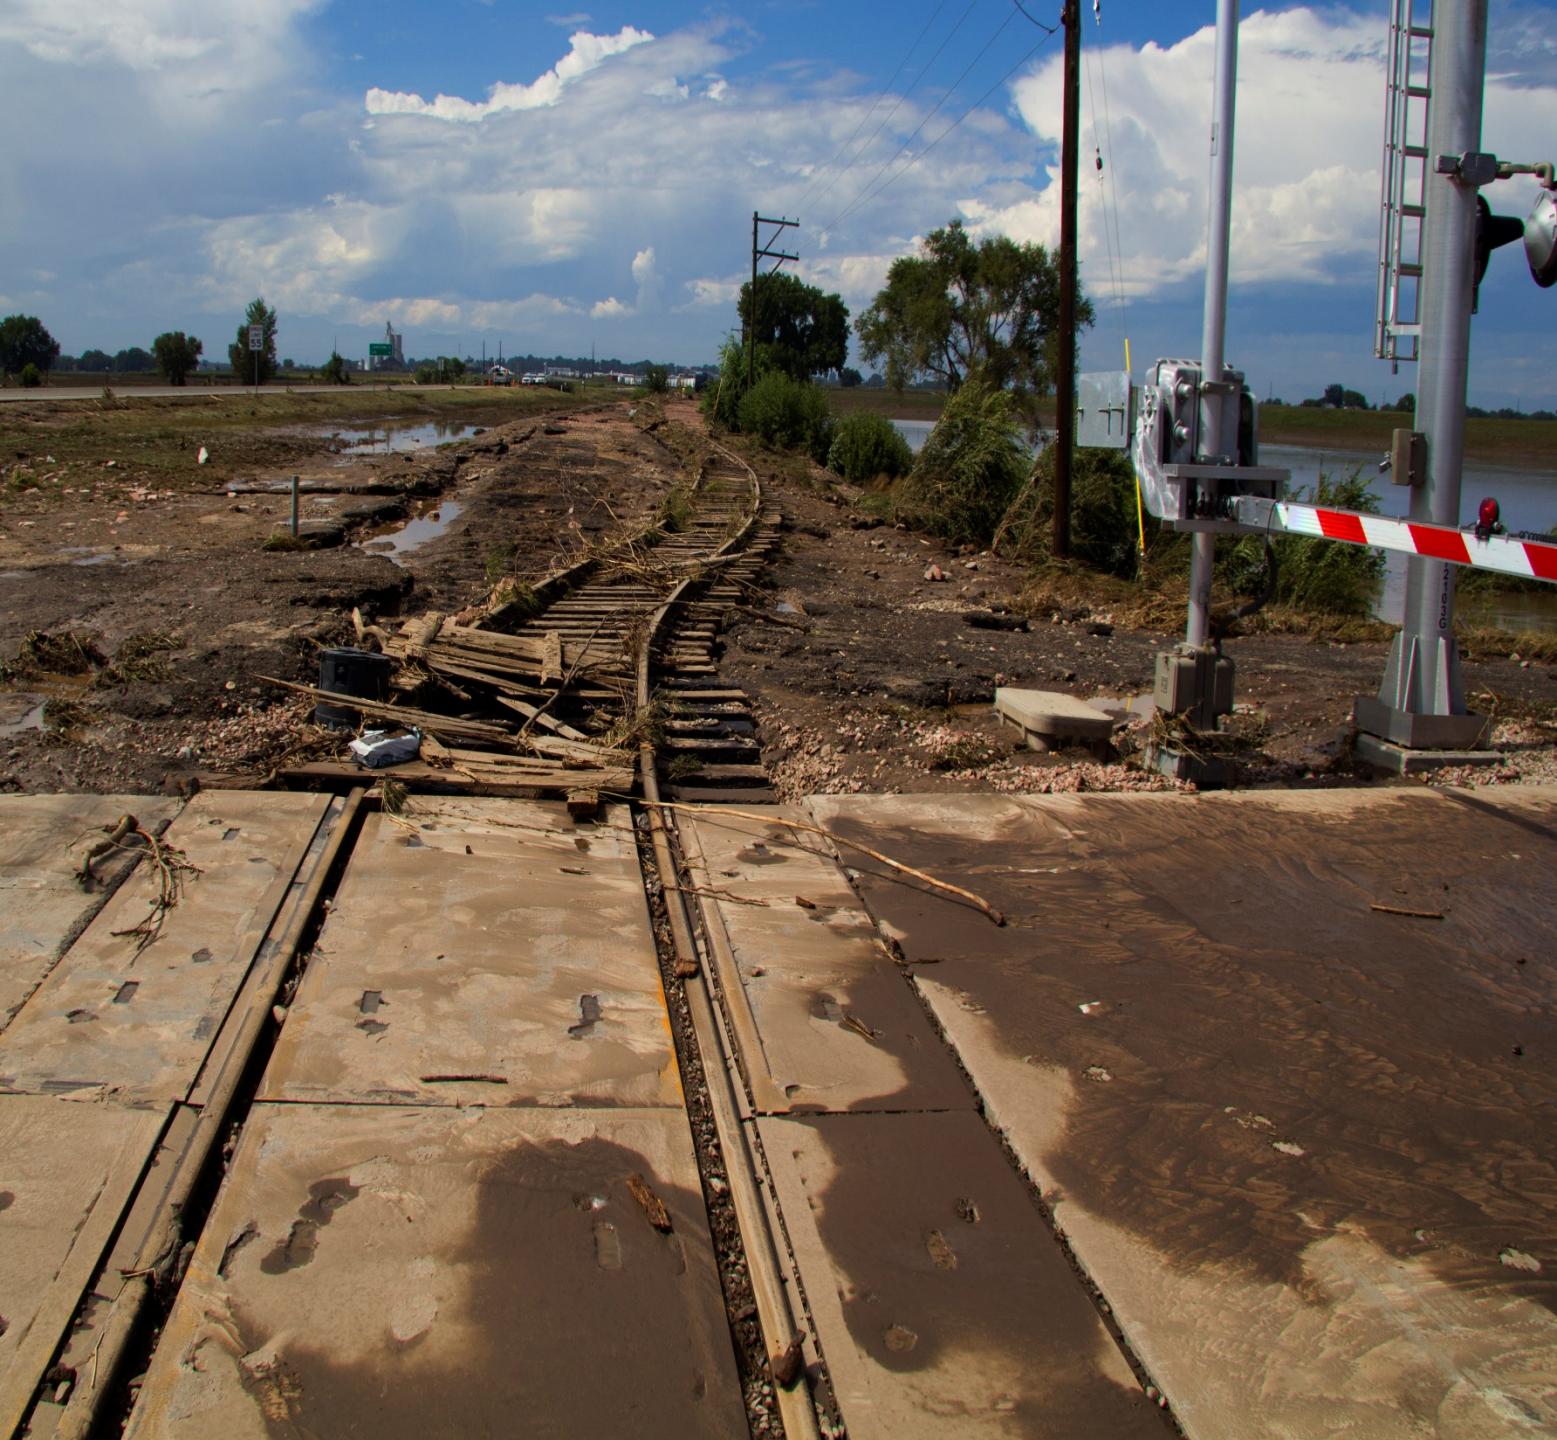
Debris (Natural and Otherwise)

1. State and Federal highway bridges survived, though bridge approaches failed
2. Debris dams, particularly in affected canyons, may have caused the most catastrophic damage

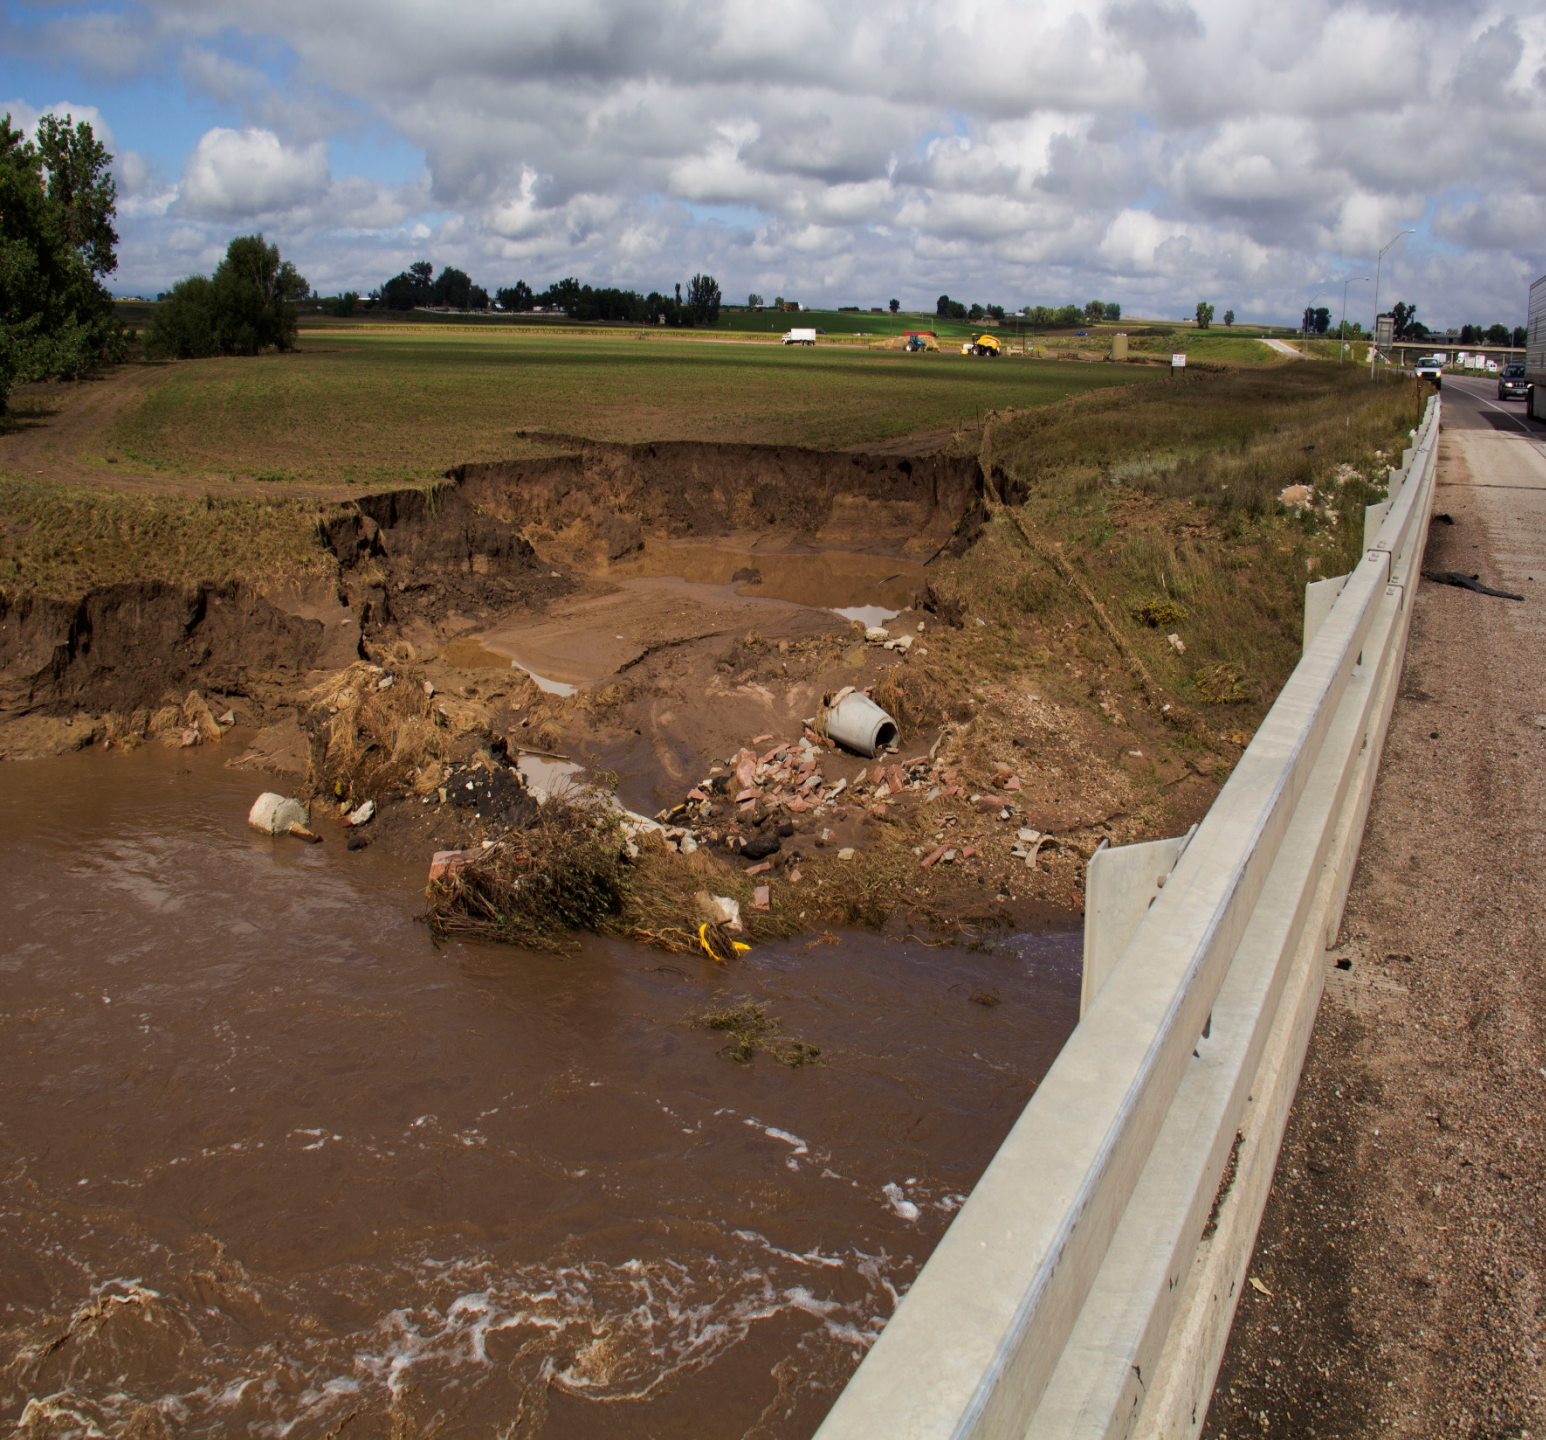
Railroads, Utilities, and Trails

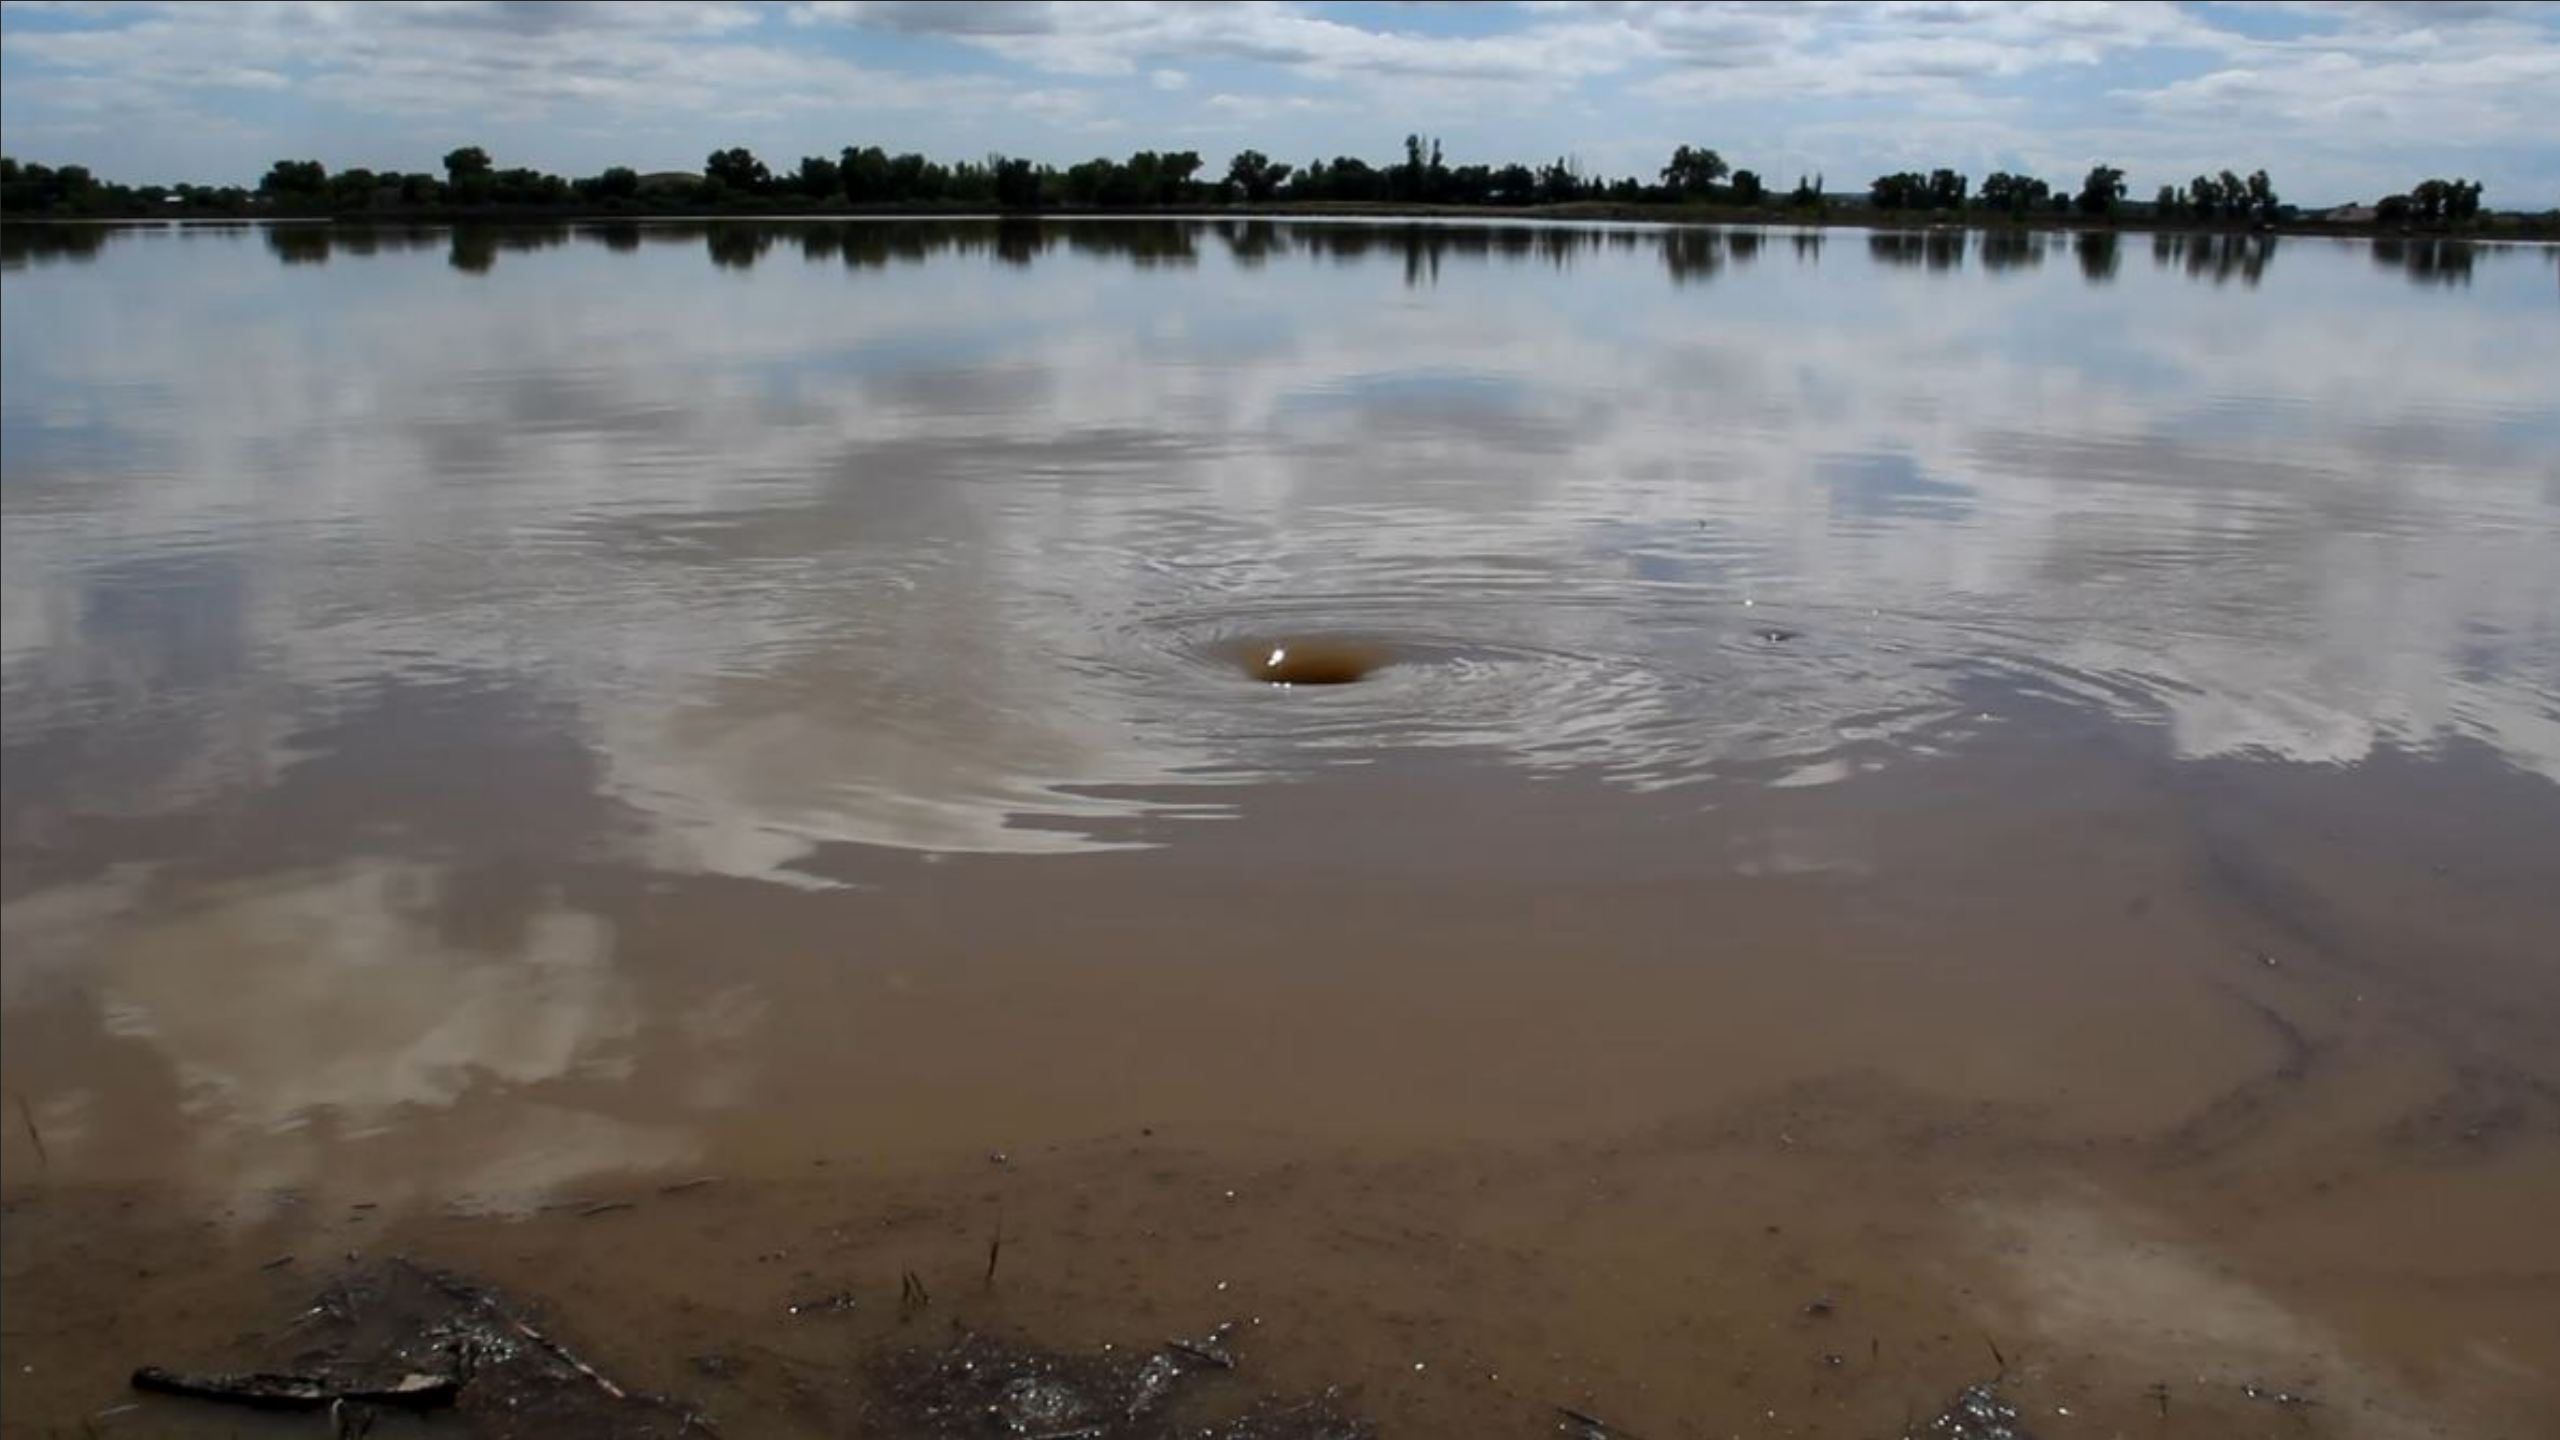
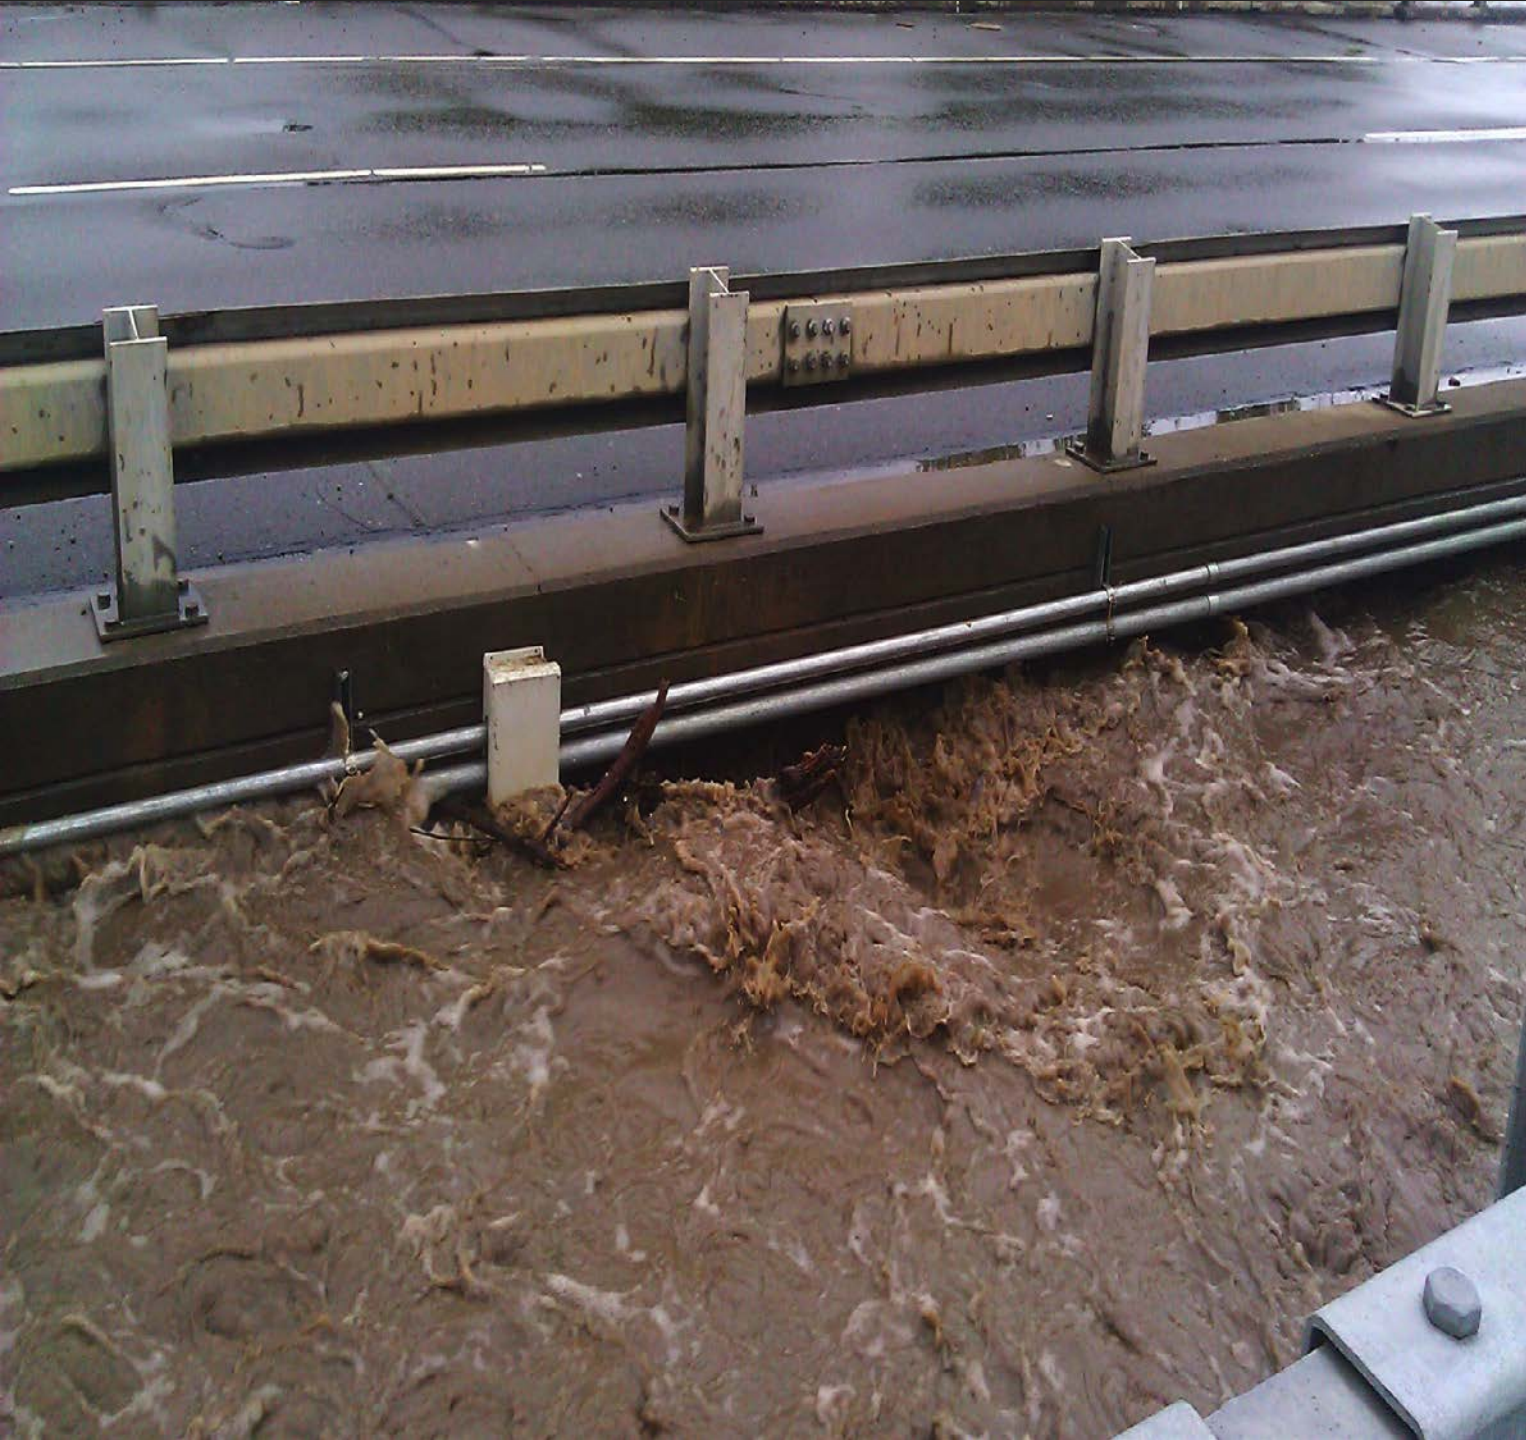
Headcuts in Fields and Front Yards

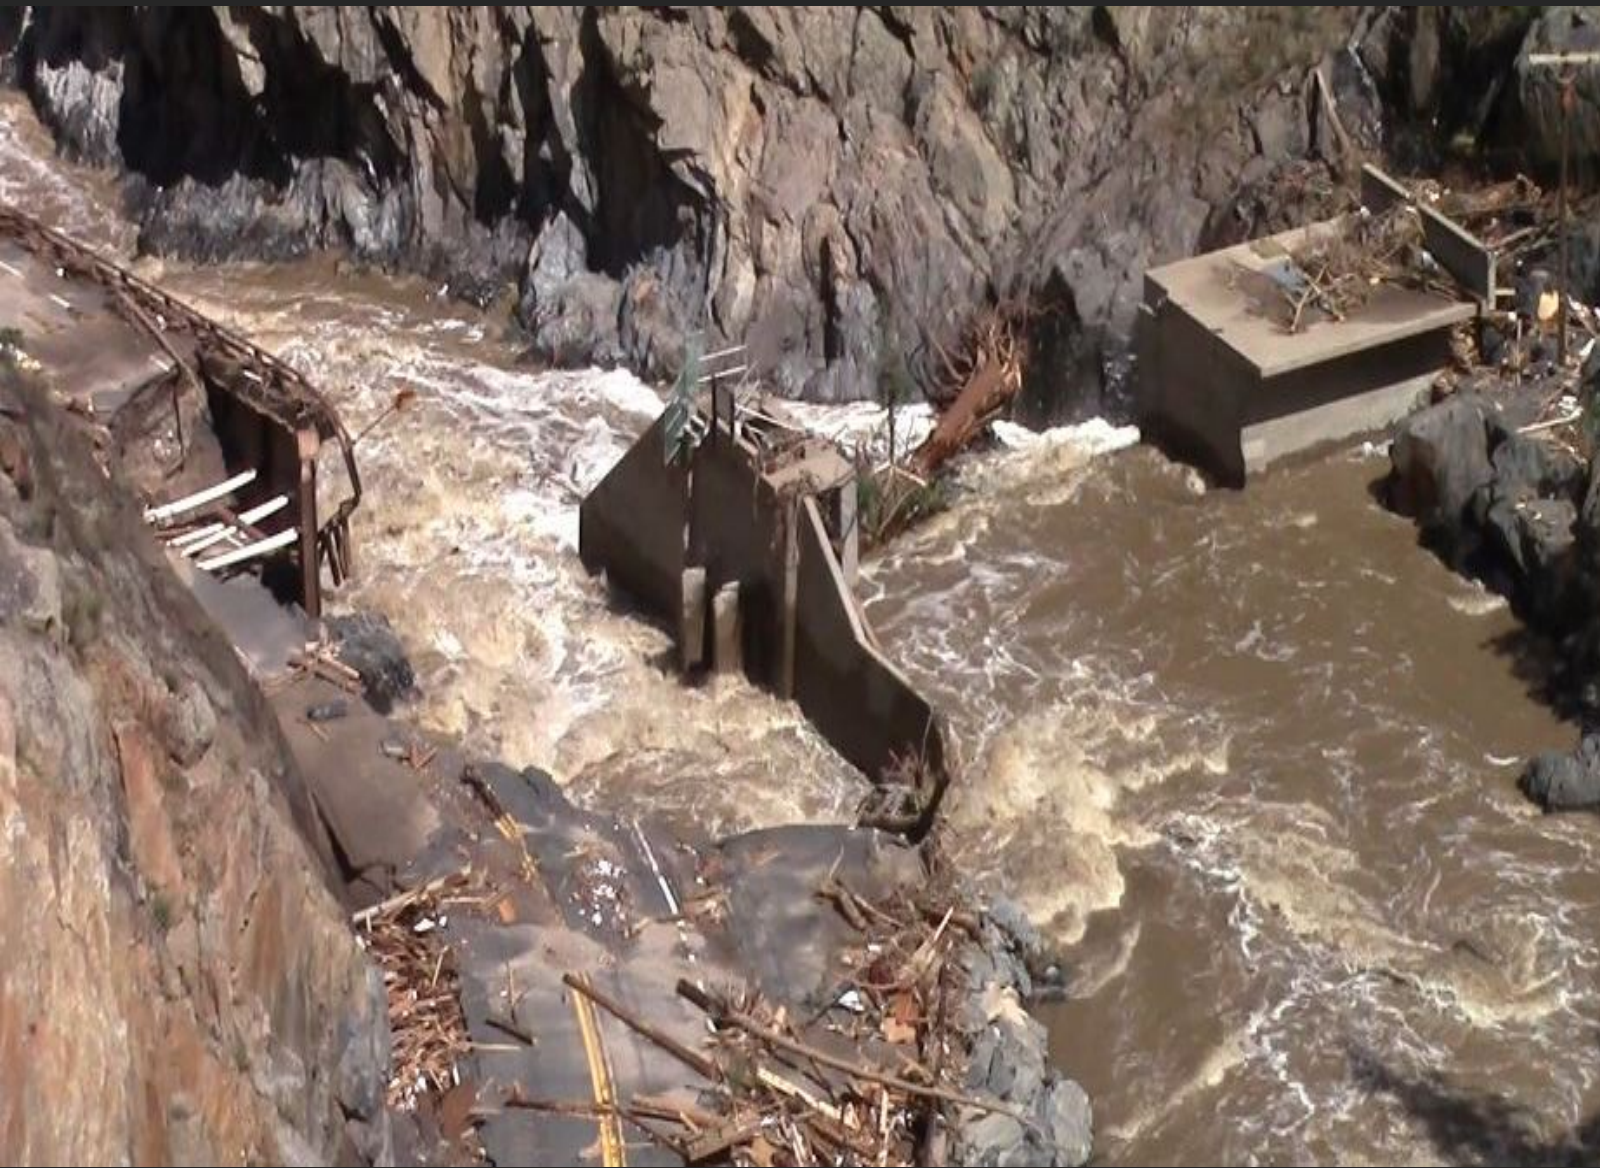
**Pressurized
Bridge Flows and
Increased
Resultant Scour**
