The September 2013 Flood: What We Saw, and What It Might Mean

Steven Griffin, PE, CFM
Region 4 Hydraulics Engineer

COLORADO
Department of
Transportation

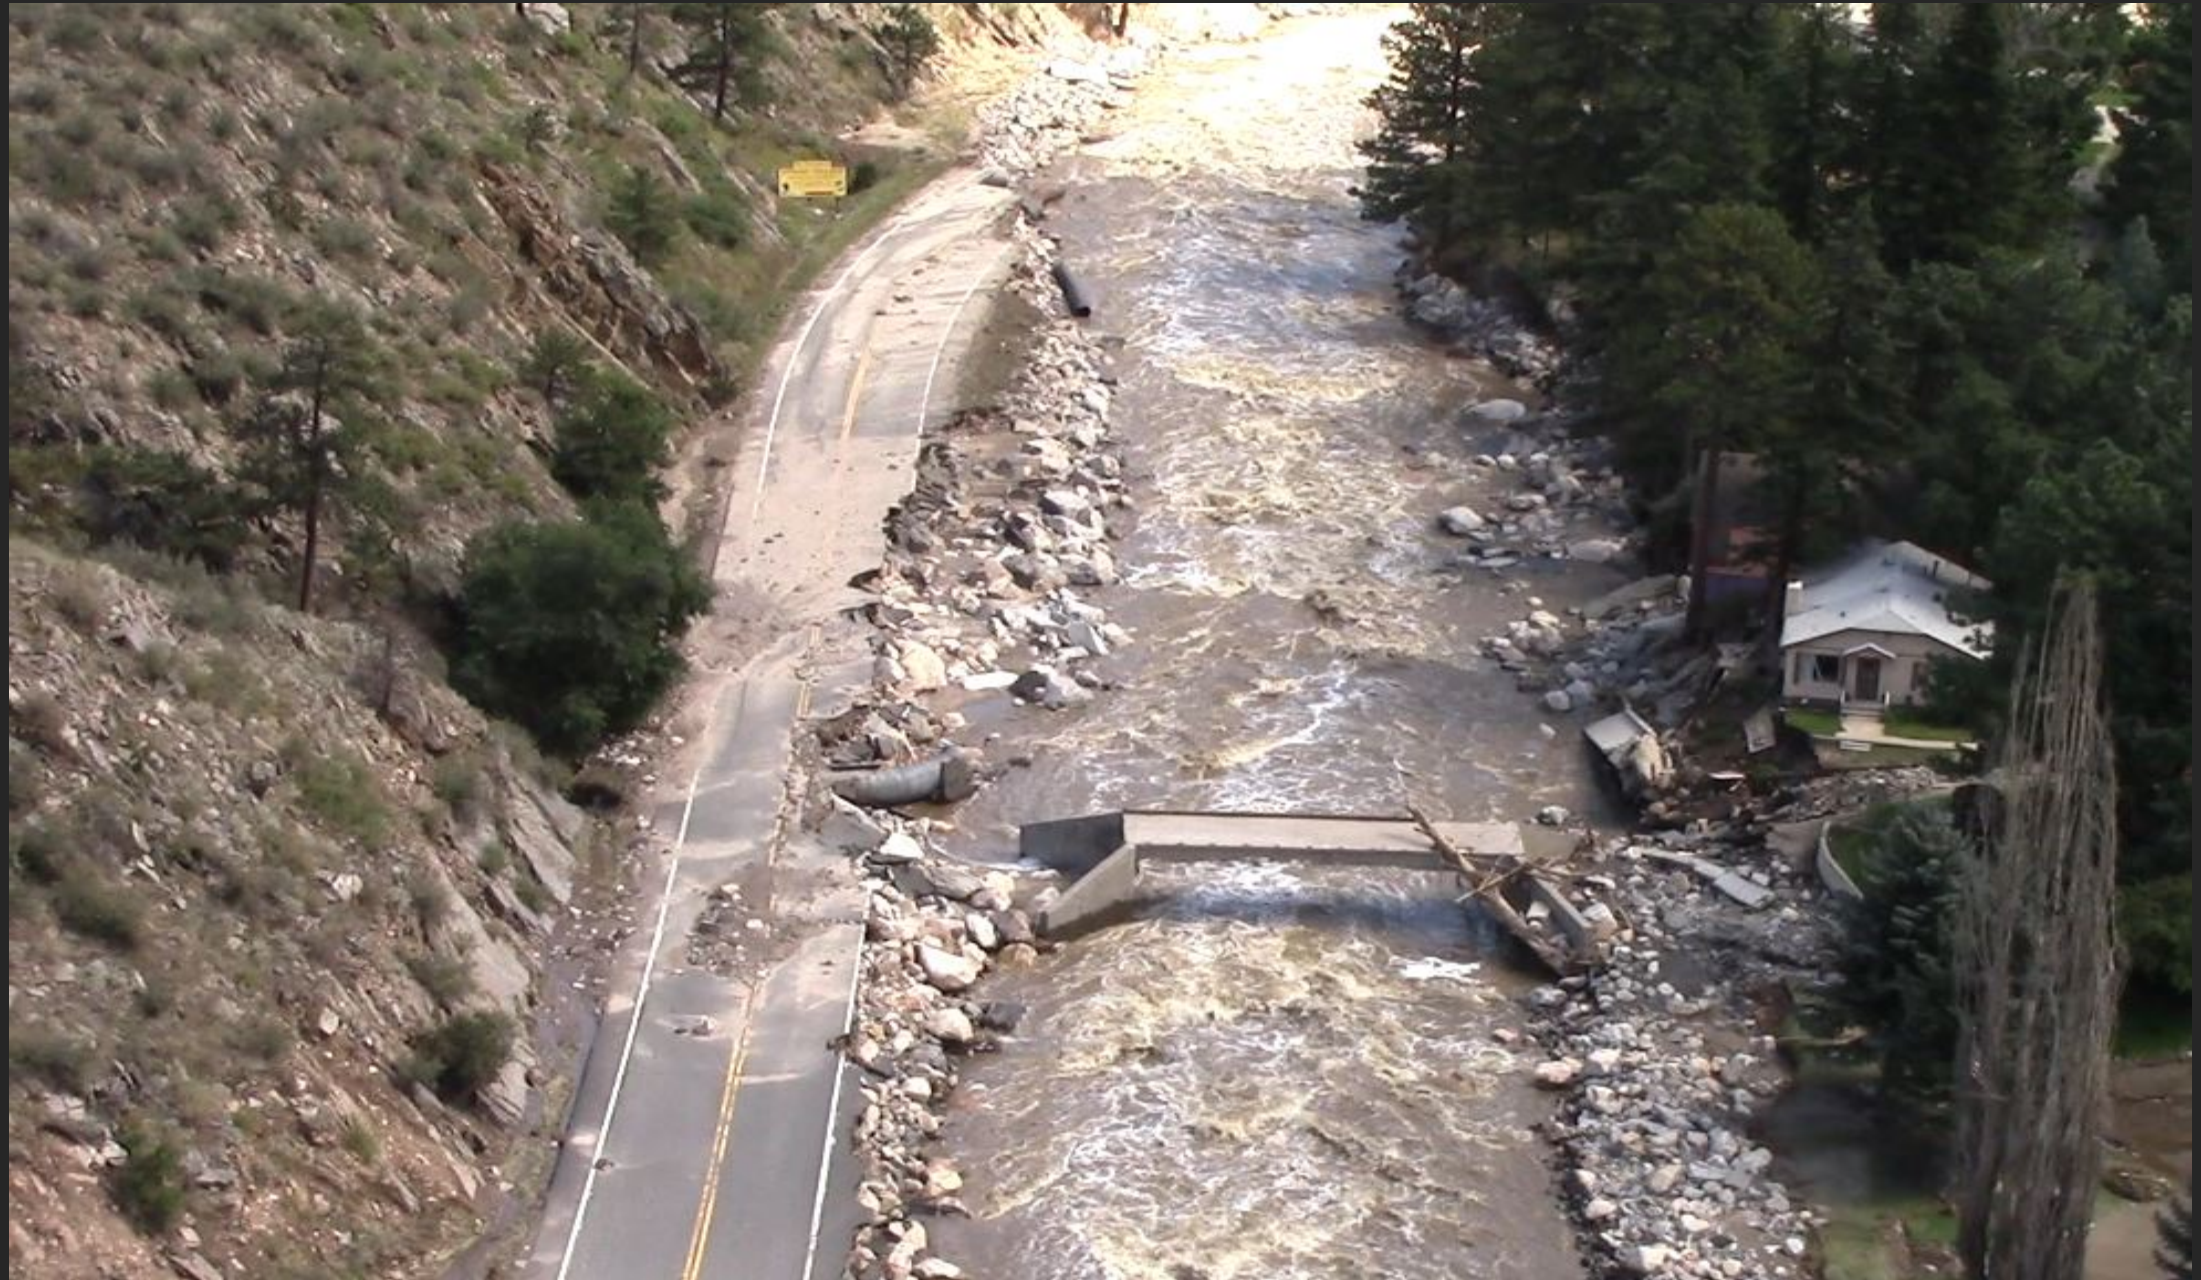
Failure of Irrigation Diversions

Ditches Run Full,
Including
Abandoned Ones

Canyon Road Systems Heavily Damaged

4. Abandoned conveyance infrastructure filled with water, leading channelized flow to “unexpected” places

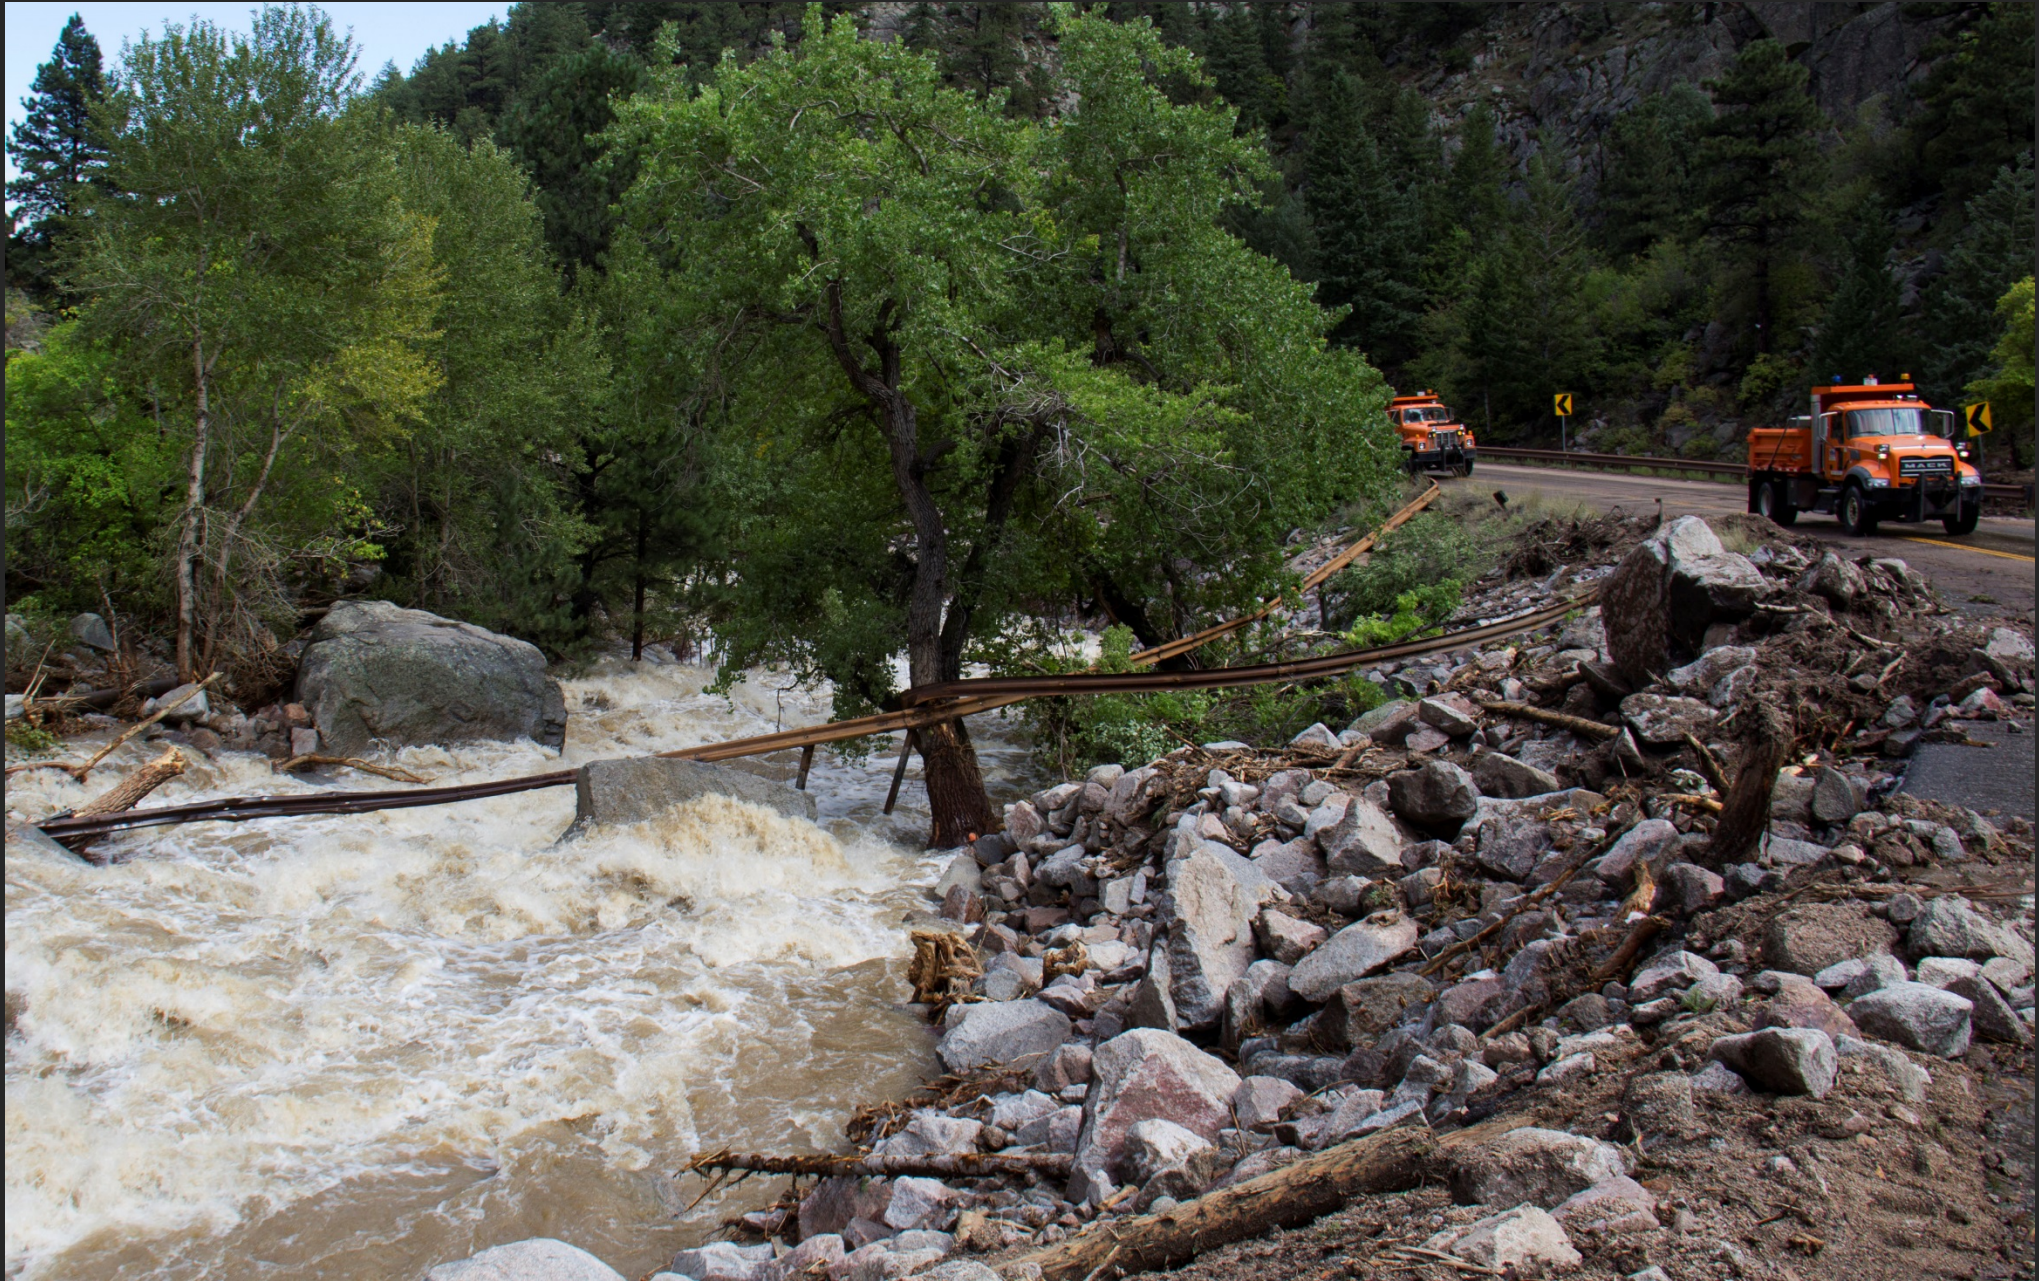
Side Slope Failures and Rockslides

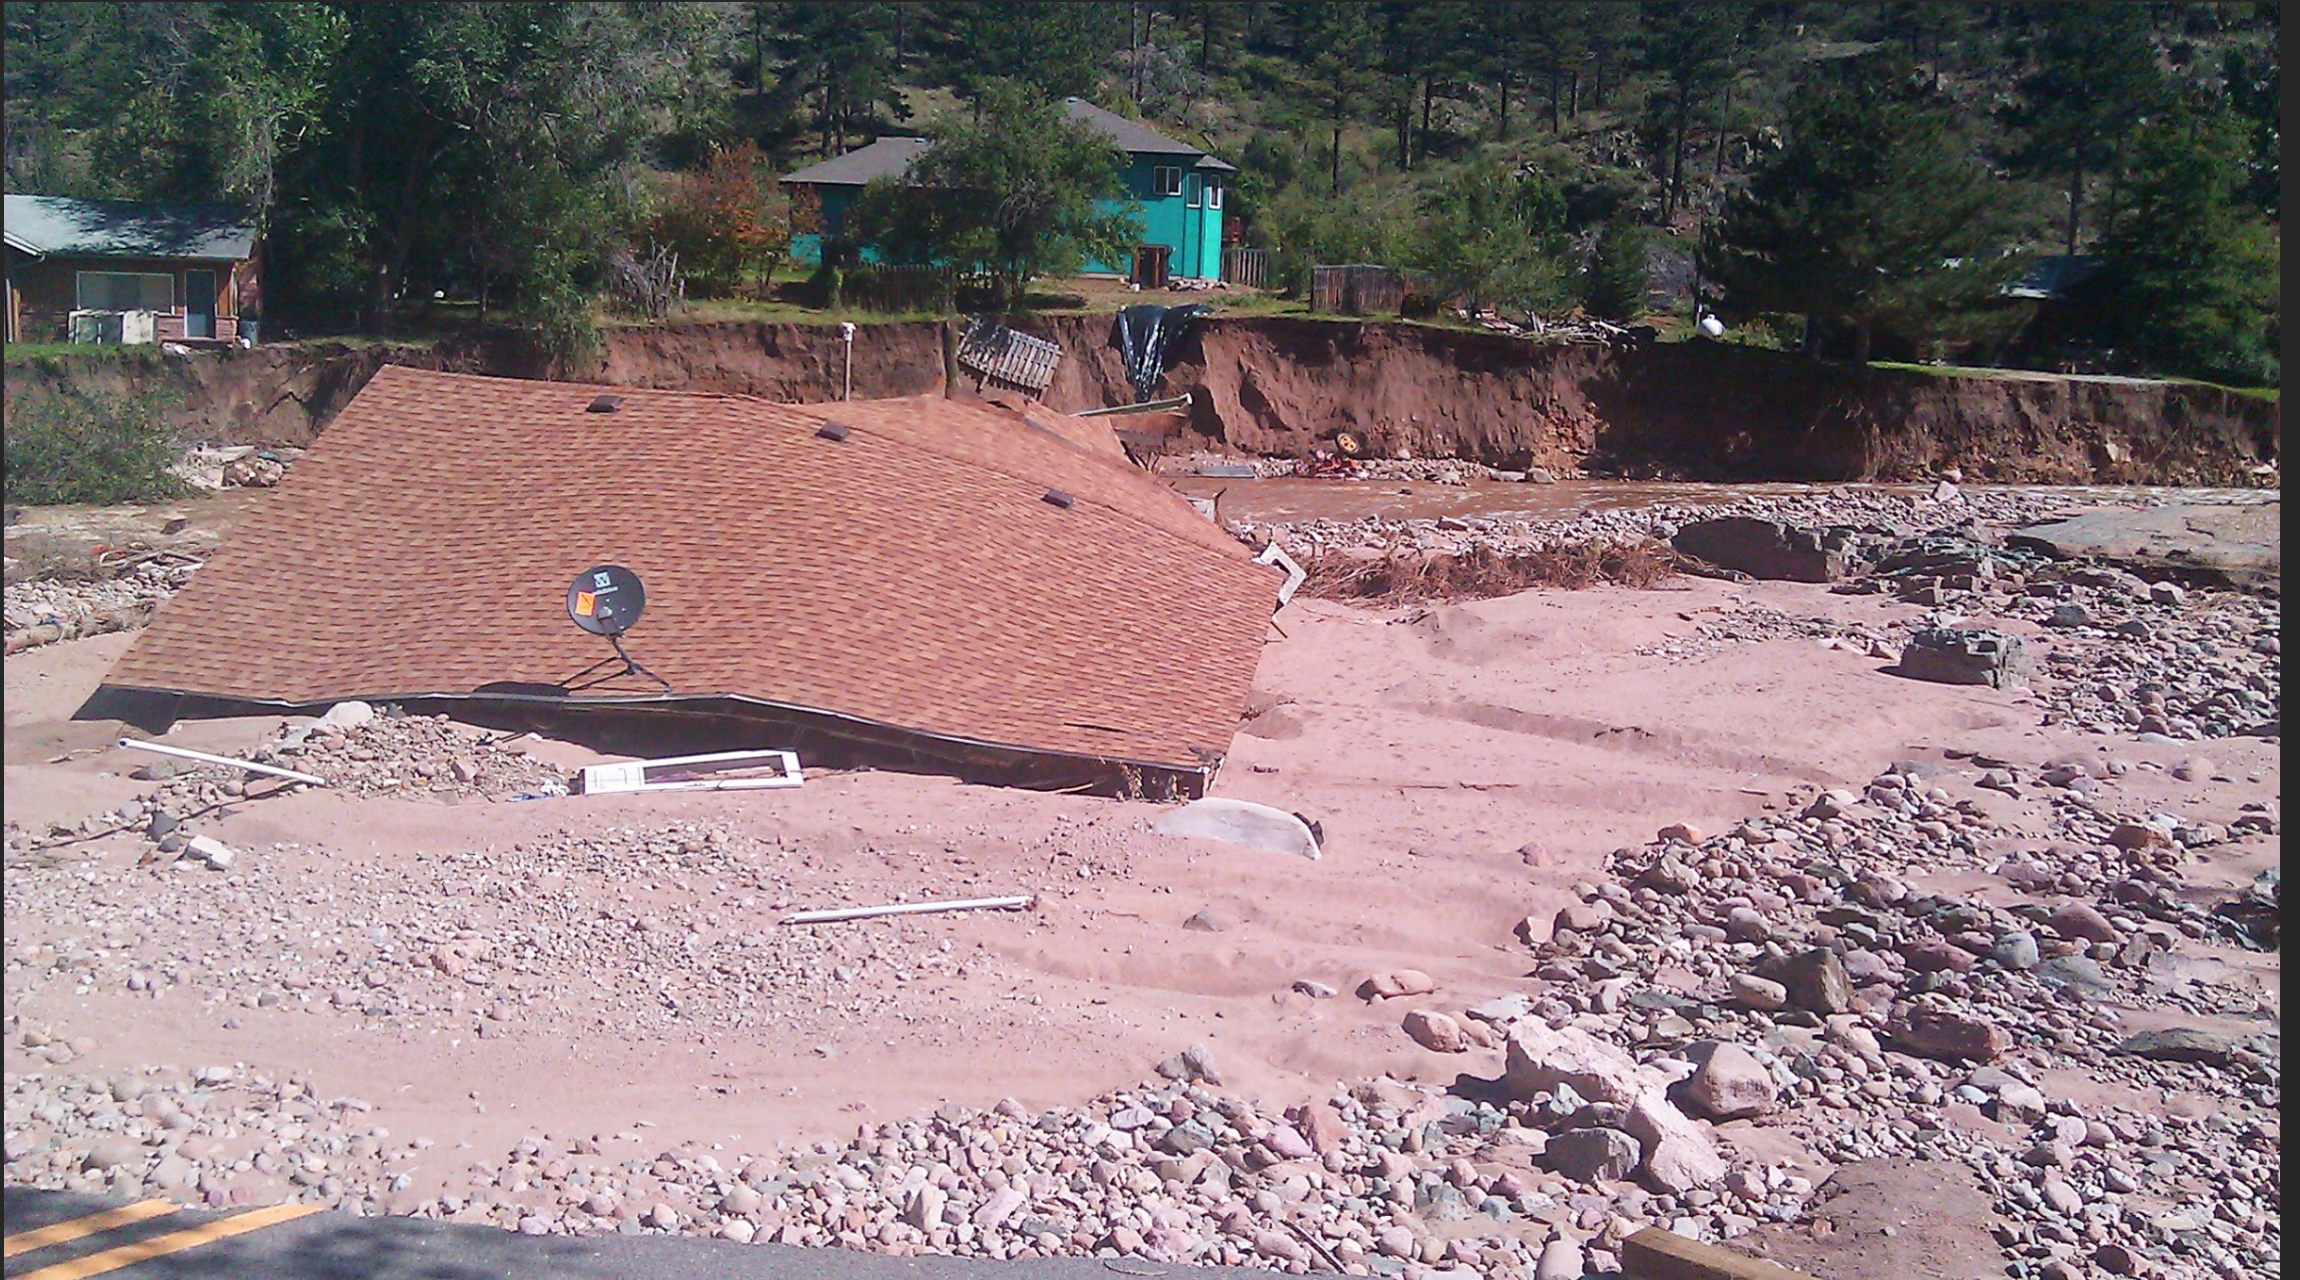
Mass Sediment Transport

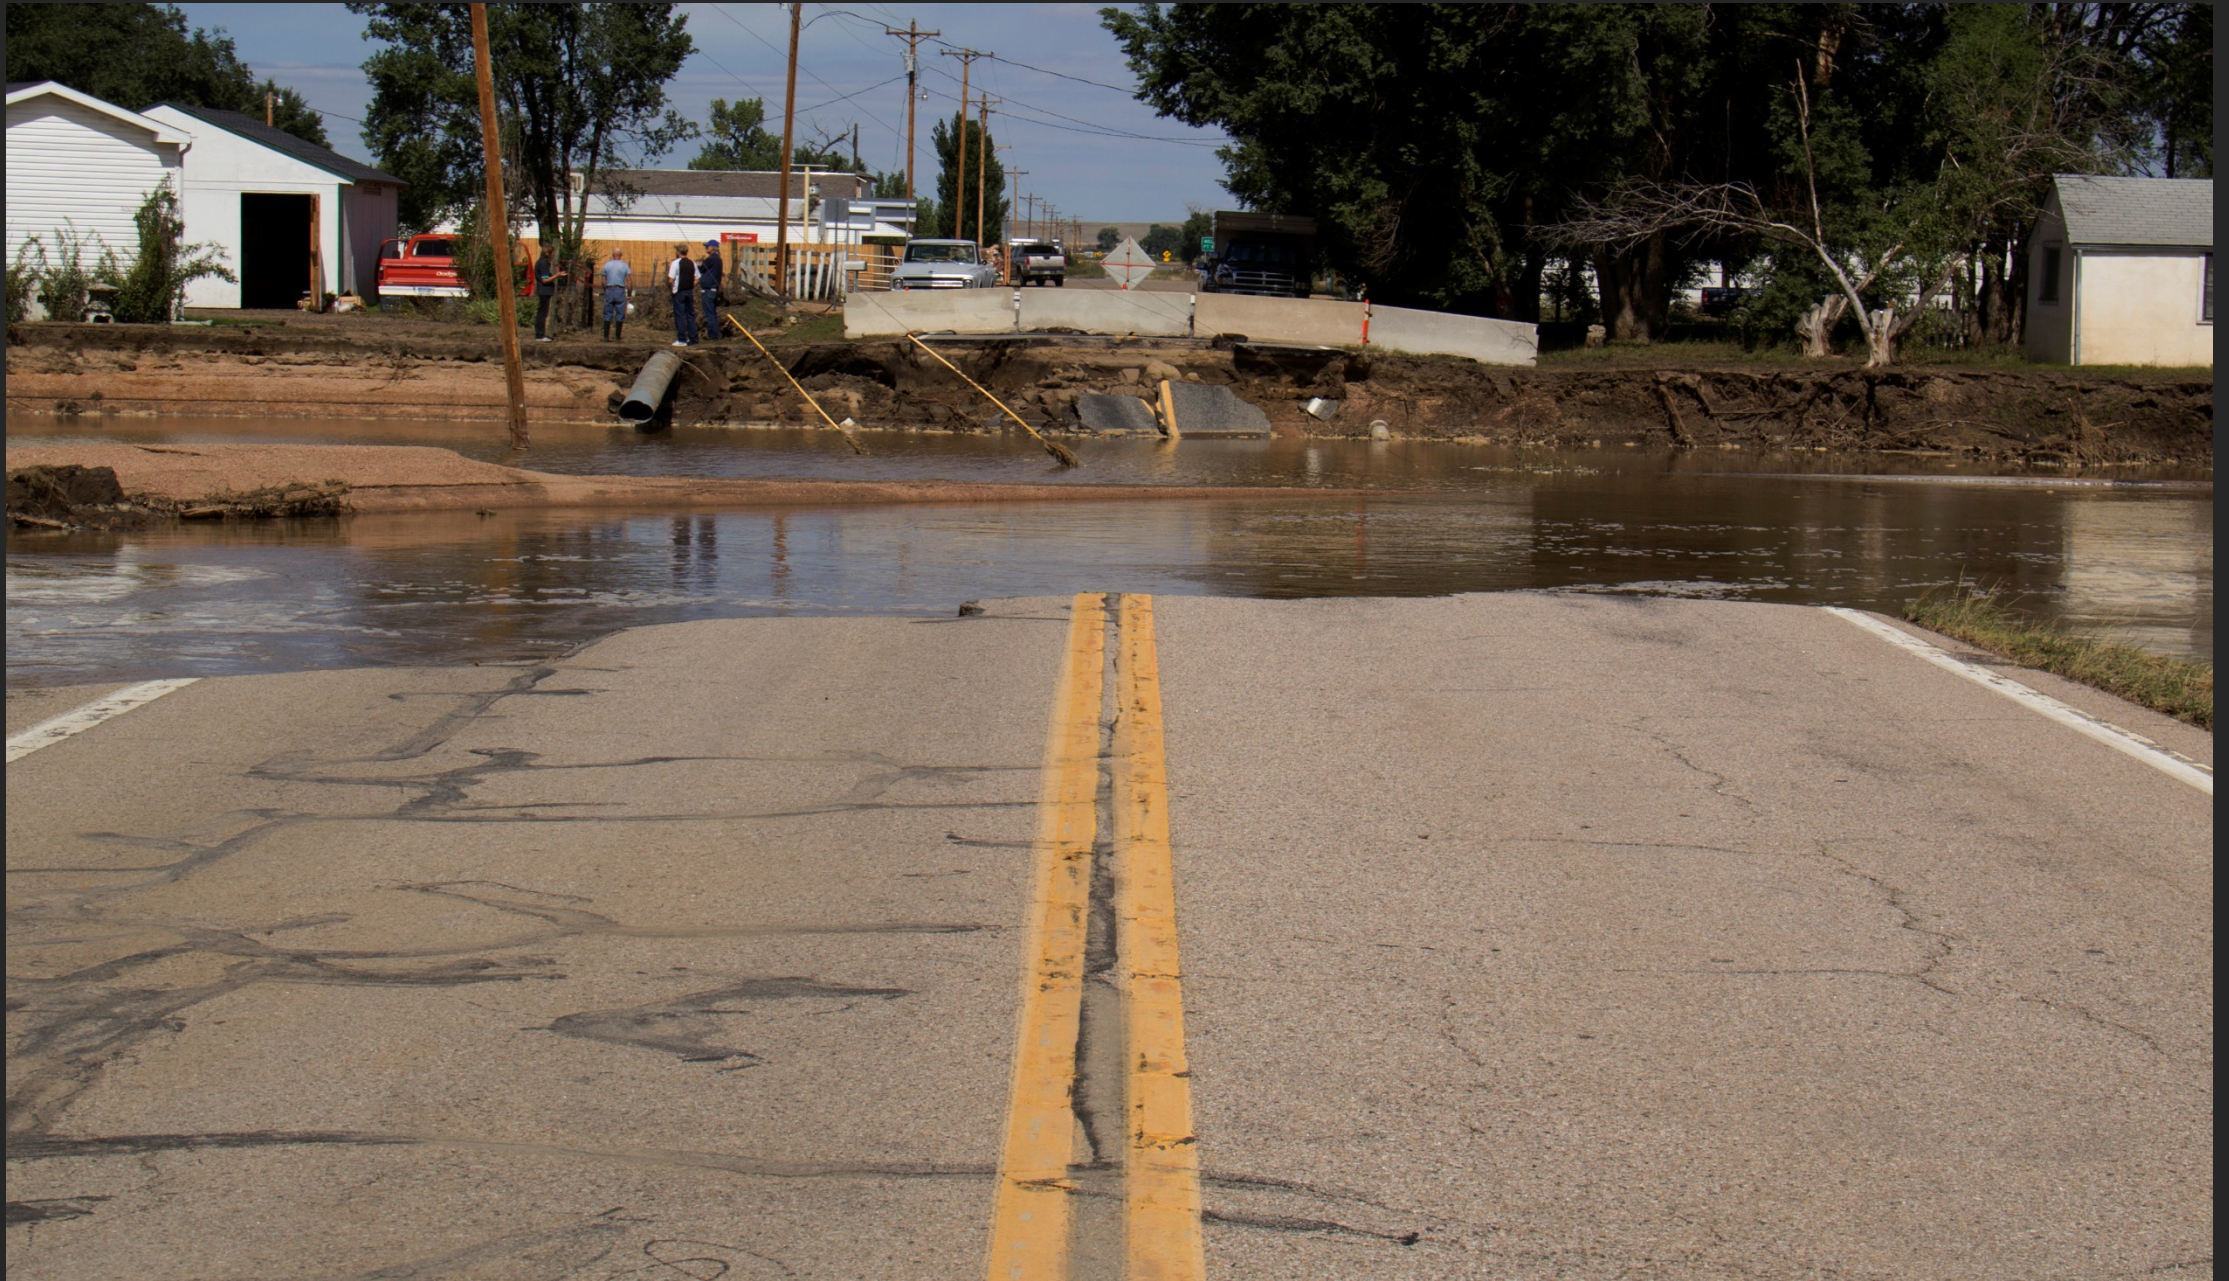
Community Access is Compromised
