BridgeWatch at ITD

Tennessee DOT's Implementation

Using BridgeWatch to Monitor Road Overtopping

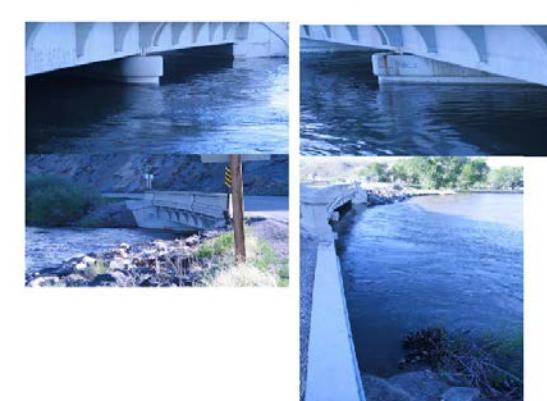
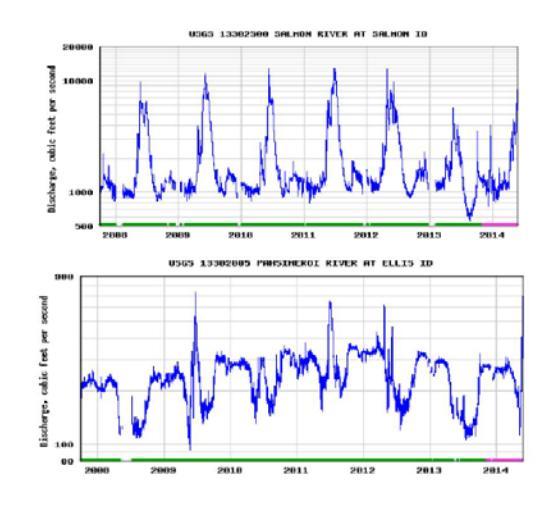
I asked the local maintenance engineer (Ken Hahn) and have his staff take a look for obvious signs of settlement. They sent the pictures linked below. There does not appear to be any or the gauge at the Pahsimeroi Raver. Although historical gauge information (distanced below) shows that this is regular annual flow for the Salmon and the Pahsimeroi gauge is at a 10 year high.

The water appears to be receding as of 5/29/14. I will continue to monitor flows over the next week. I will add bridge to the watch list, when the scheduled underwater inspection occurs observed scour will be compared to previous reports.

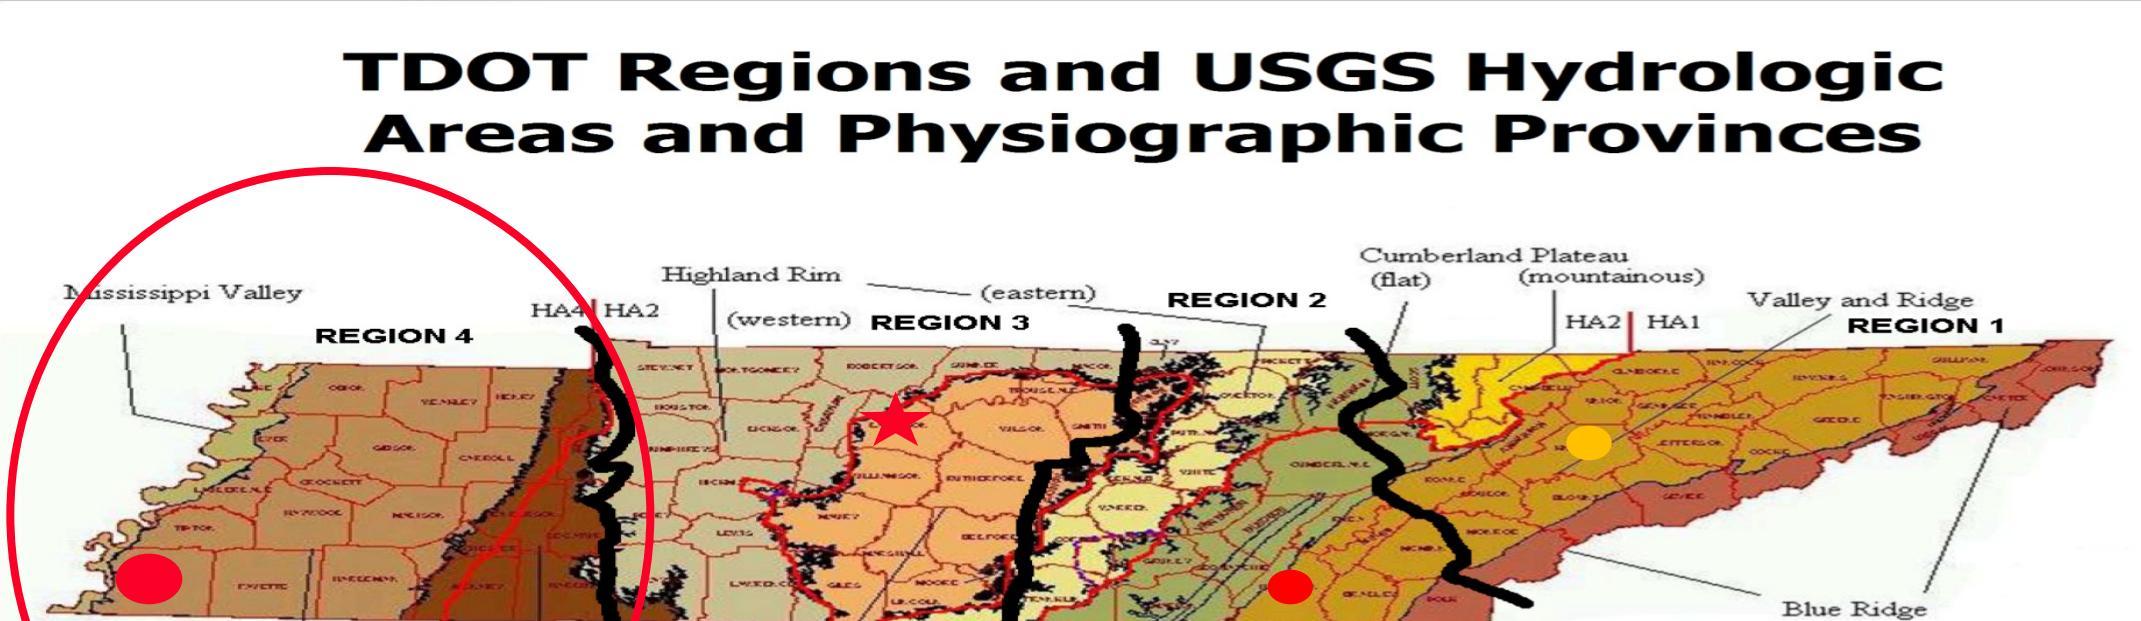
Regions of Tennessee

TDOT Region Boundary
 Updated hydrologic area boundary (2001)

Previous hydrologic area boundary (1993)
