An Iowa Barn: Swedish Style

by Pat Sonquist Lane

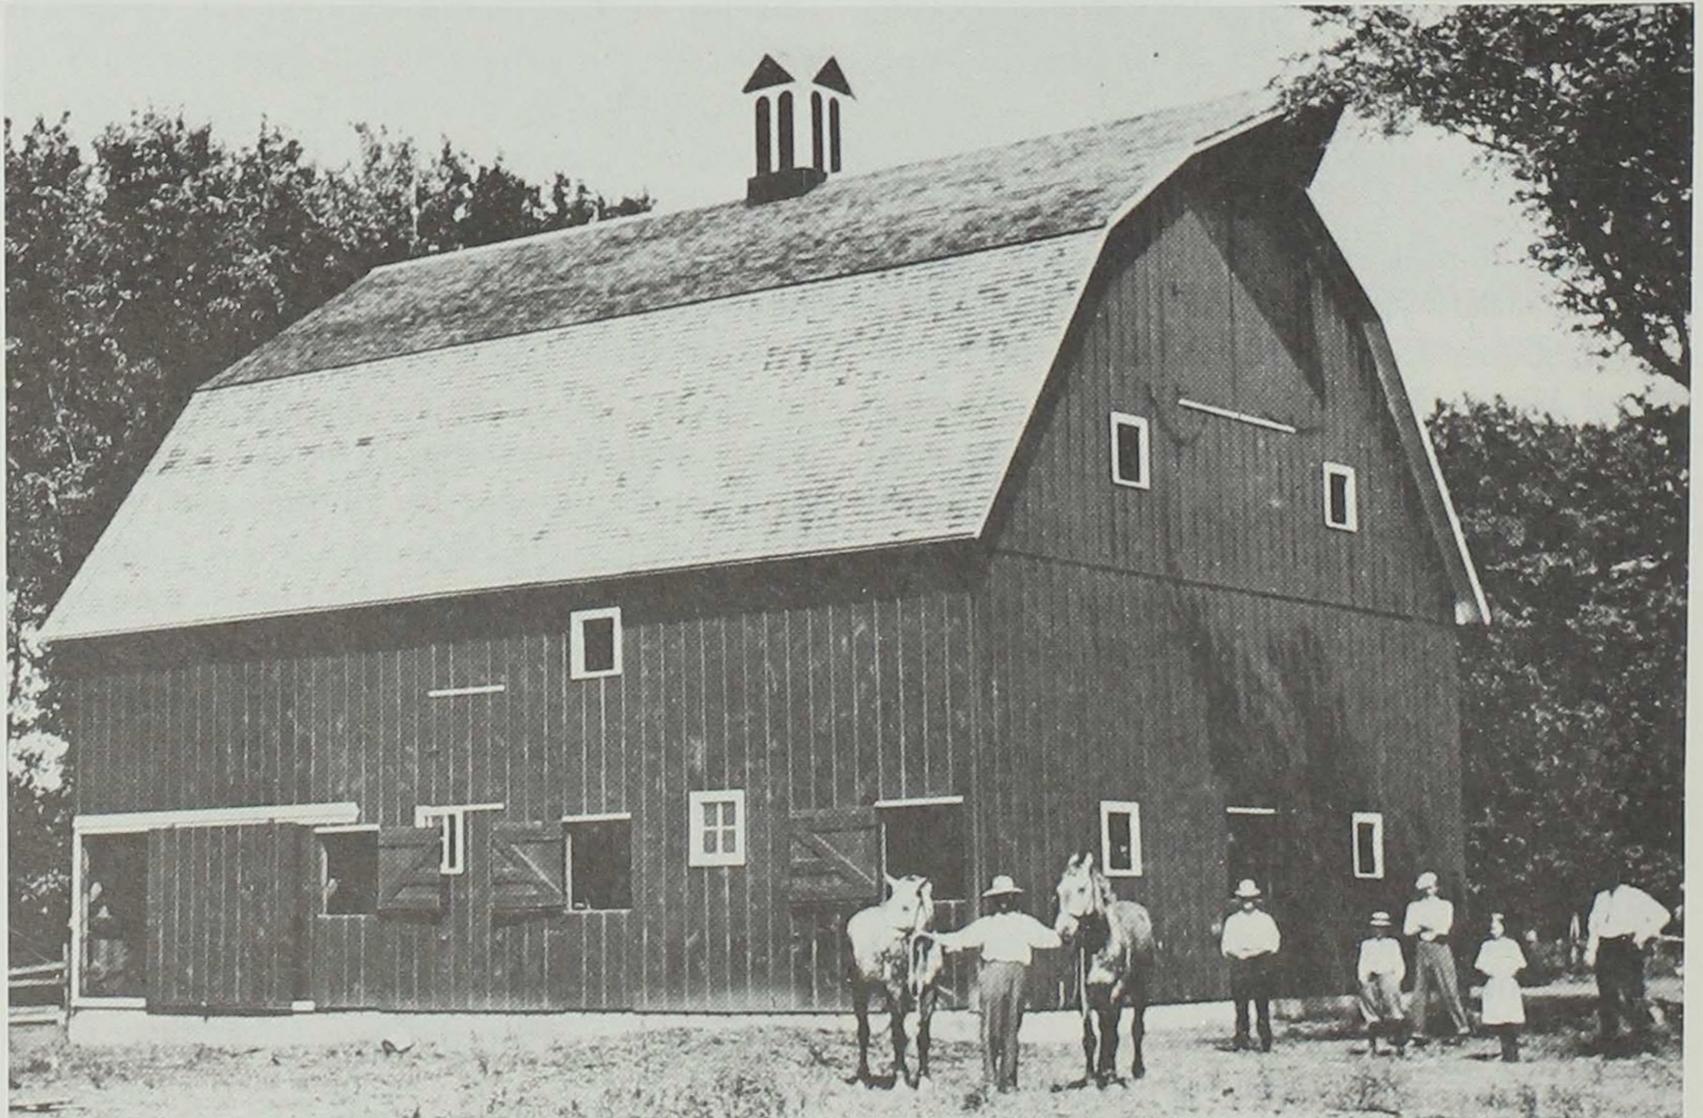
The Sonquist barn, built with a pegged frame using the Swedish method, in 1913. From left to right: Charles Sonquist holding the horses, Ernest Peterson, Verner, Leslie, and Helen Sonquist, and Frank Bloomquist. (courtesy the author)

"The barn was built as they were in Sweden, no nails in the frame, put together with pegs. It was 50 feet long and 40 feet wide. Frames were made lying on the ground." In her letter containing this description of the barn on the Sonquist Home Place, Hazel Manguson Sonquist included a photograph of it. It was built in 1913 and is "still standing straight and strong."

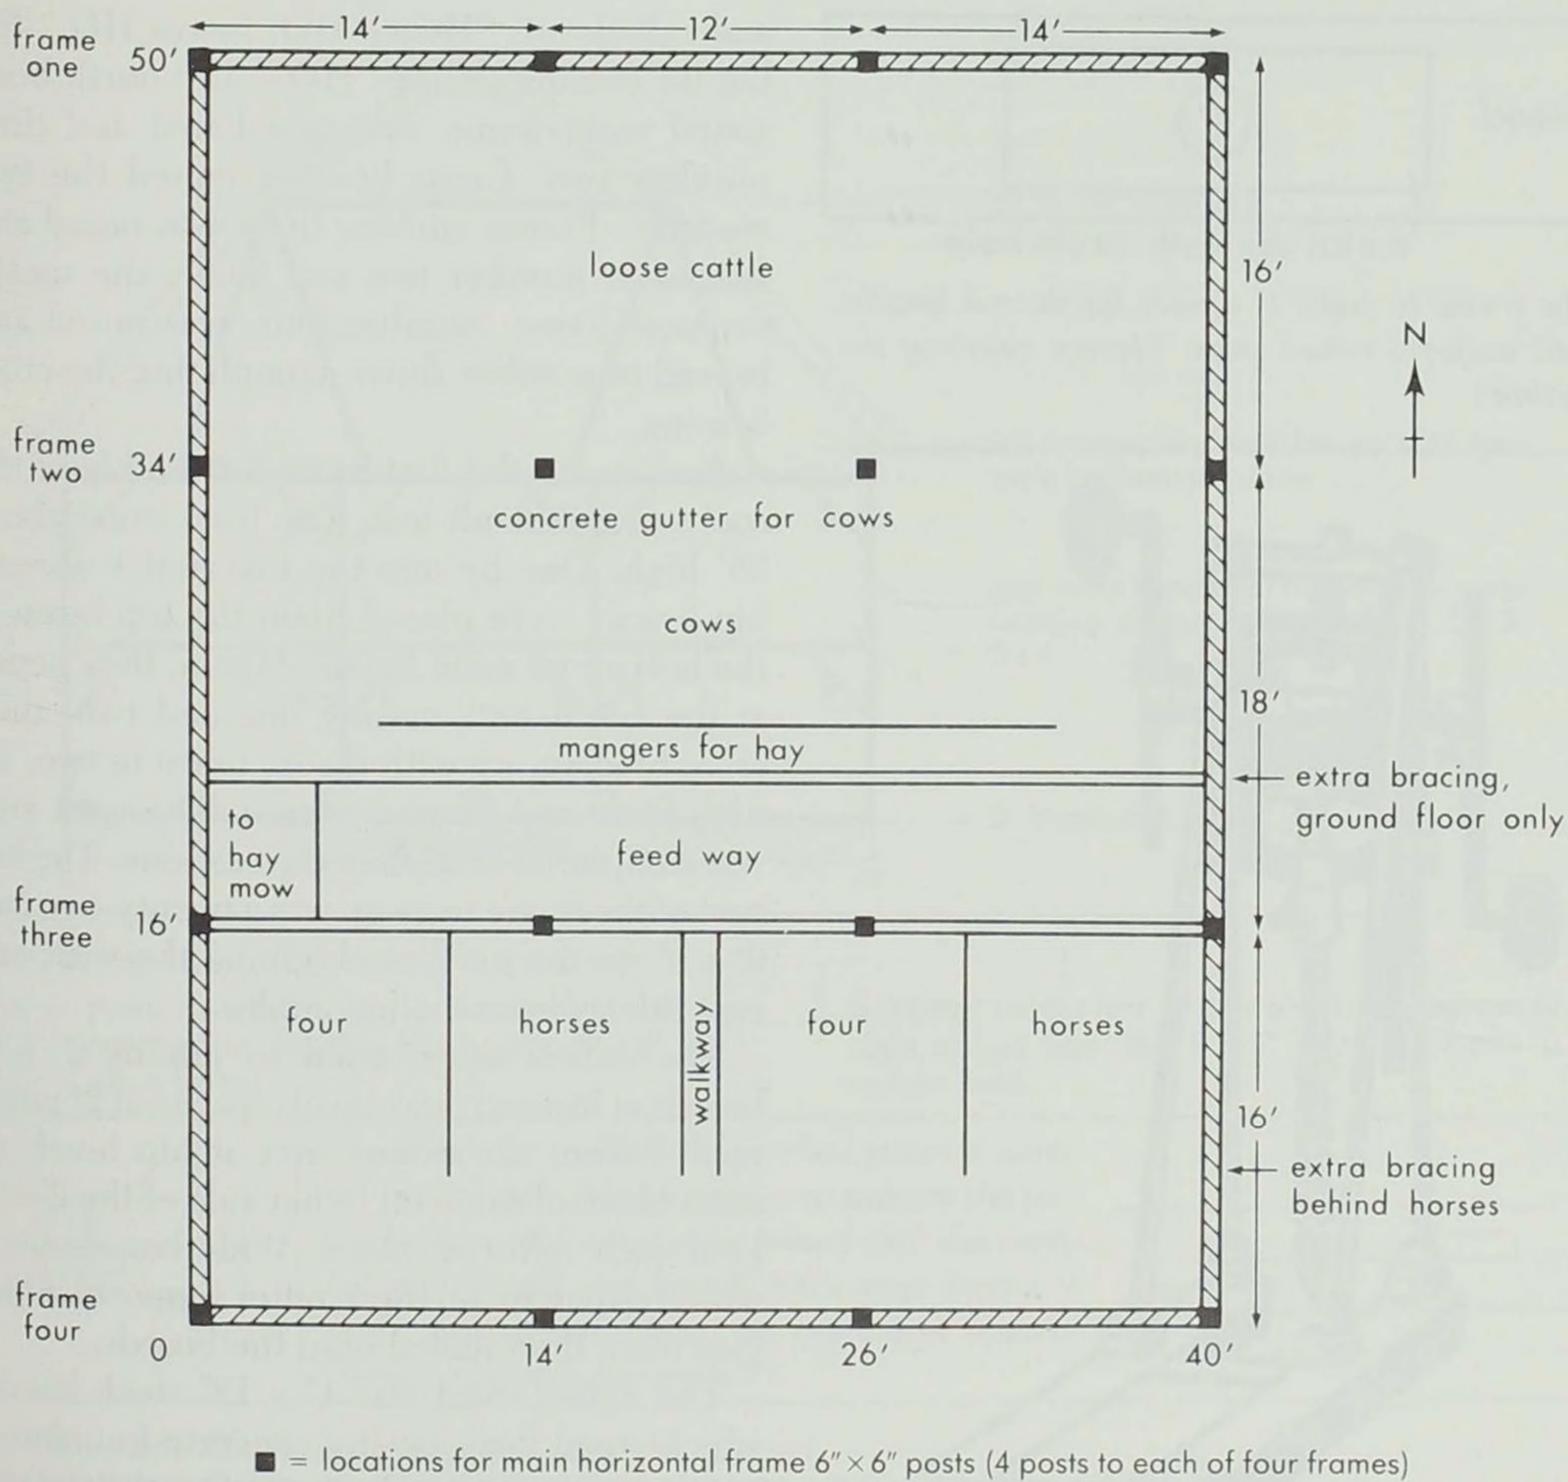
The floor plan of the Sonquist peg frame barn. (design courtesy the author)

The 40' x 50' concrete foundation was completed in one day and left to dry while the carpentry continued. The foundation was 8" wide and averaged about 24" high, except for the northwest corner, which needed 30" to be level. A 6" x 6" sill was bolted to the entire cement foundation, except for the twelve 6" x

6" openings into which the legs of the four horizontal main frames would be pulled into place. Carbide cans 2' long and 15" wide were used as forms for the four interior supports. A bolt was placed in this support form and the 6" x 6" post was set on the bolt. A concrete floor for the cows with a gutter to the back was poured, extending around the four concrete interior supports. There was dirt under the horses at that time, a cement block being added much later.

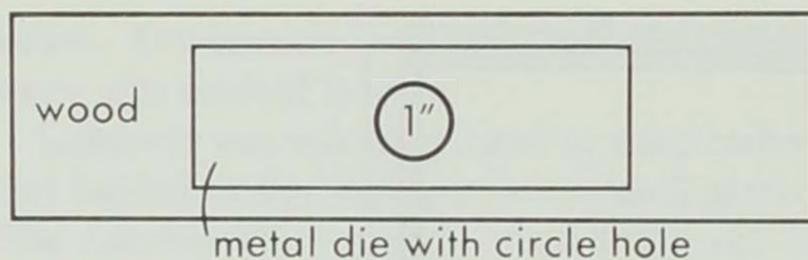
The frame to make 1" square hardwood lengths into uniform round pegs. (design courtesy the author)

pegs were made out of hardwood. Lengths of oak about 1" square were cut, then driven through a metal die attached to a strong frame. This made a uniform wooden peg. The pegs were sawed off flush with the wood surface after being hammered into place. A drilling machine with a seat for the operator was used to drill the holes for the pegs. The drill could be adjusted to enter the wood at different, uniform angles. It was also used with a 2" wood bit to drill out three circles close together where a groove was needed for 4" x 4" or 6" x 6" braces

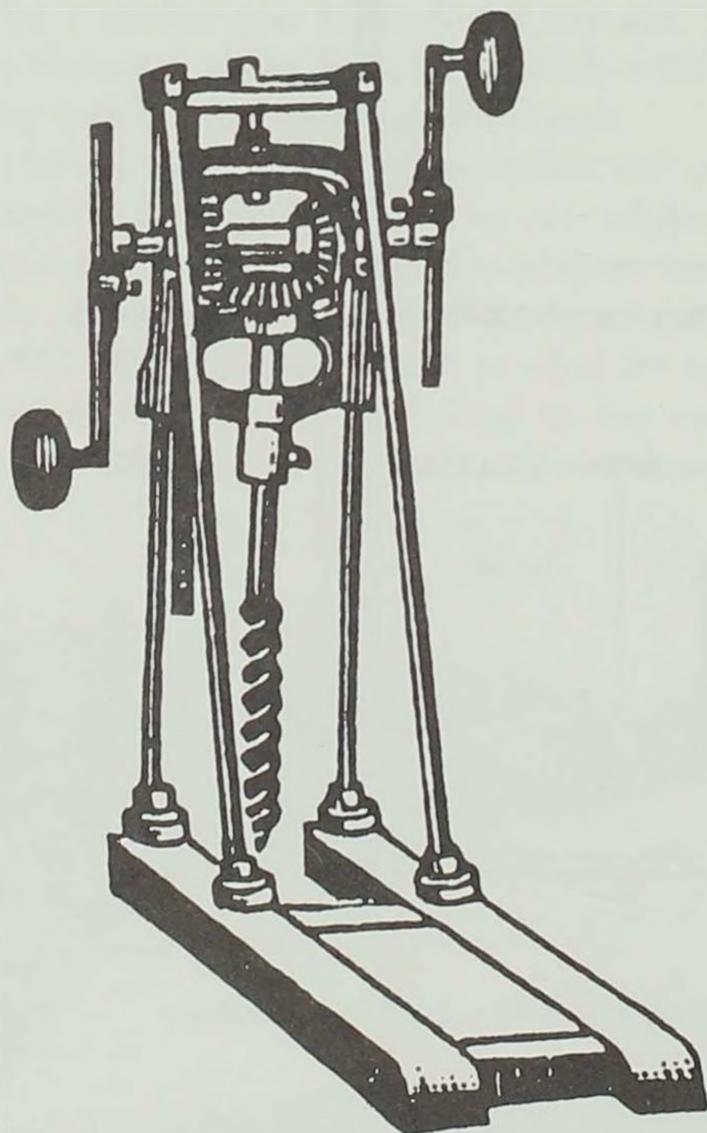
An adjustable drilling tool for peg holes and brace grooves.

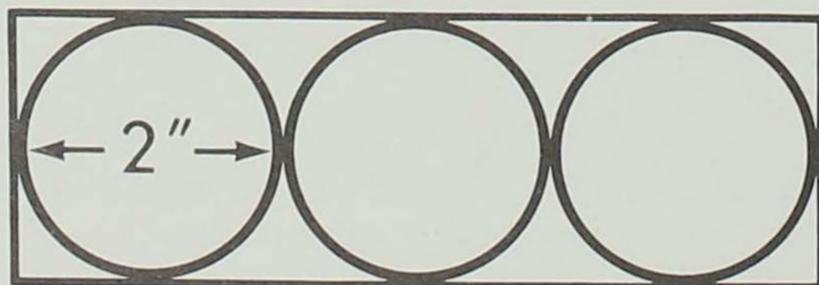
Circles were drilled with a 2" wood bit, then chiseled to make a rectangular notch to receive the braces. (design courtesy the author)

on the frame of the barn. A large wood chisel was then used to chisel the opening to the right size. Finally the horizontal frames were constructed on the ground and all the other supports and braces prepared.

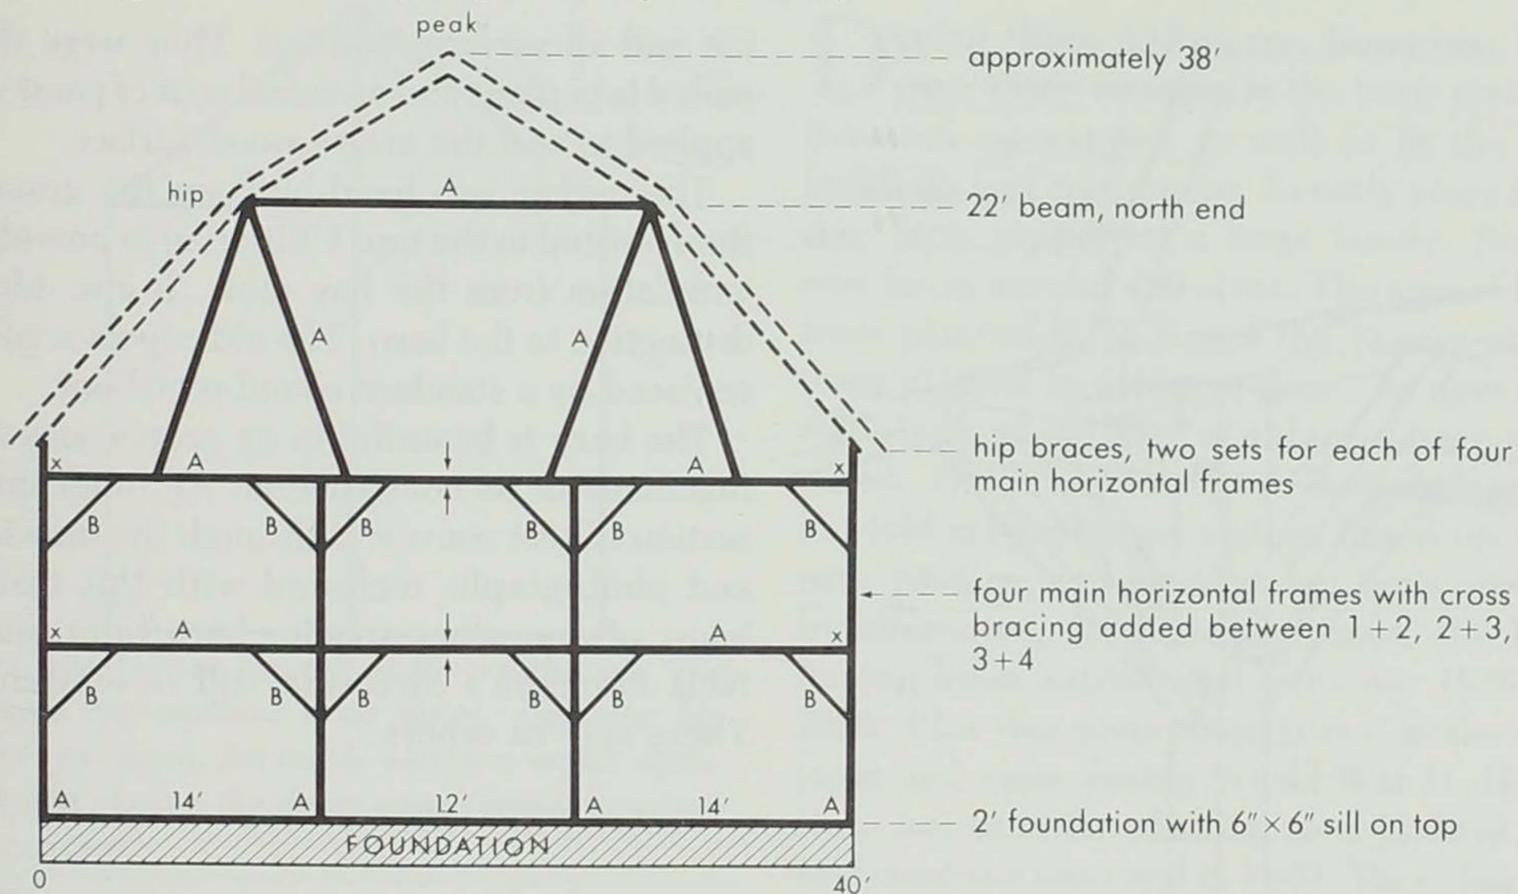
The barn, front elevation. (design courtesy the author)

A = 6" x 6" B = 4" x 4" C = 4" x 6"

x = point at which exterior vertical 6" x 6" is notched to receive horizontal 6" x 6" on main frame

↓ indicates center join of 6" x 6"s. The diagram at right shows how the 6" x 6" is cut to make a secure joint.

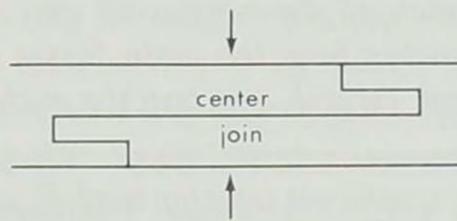
The drawings to the left (notched exterior vertical frame) and right (center join) suggest the way the horizontal frames were joined with the vertical main frame and how 6" x 6"s were joined to make horizontal beams of sufficient length. (design courtesy the author)

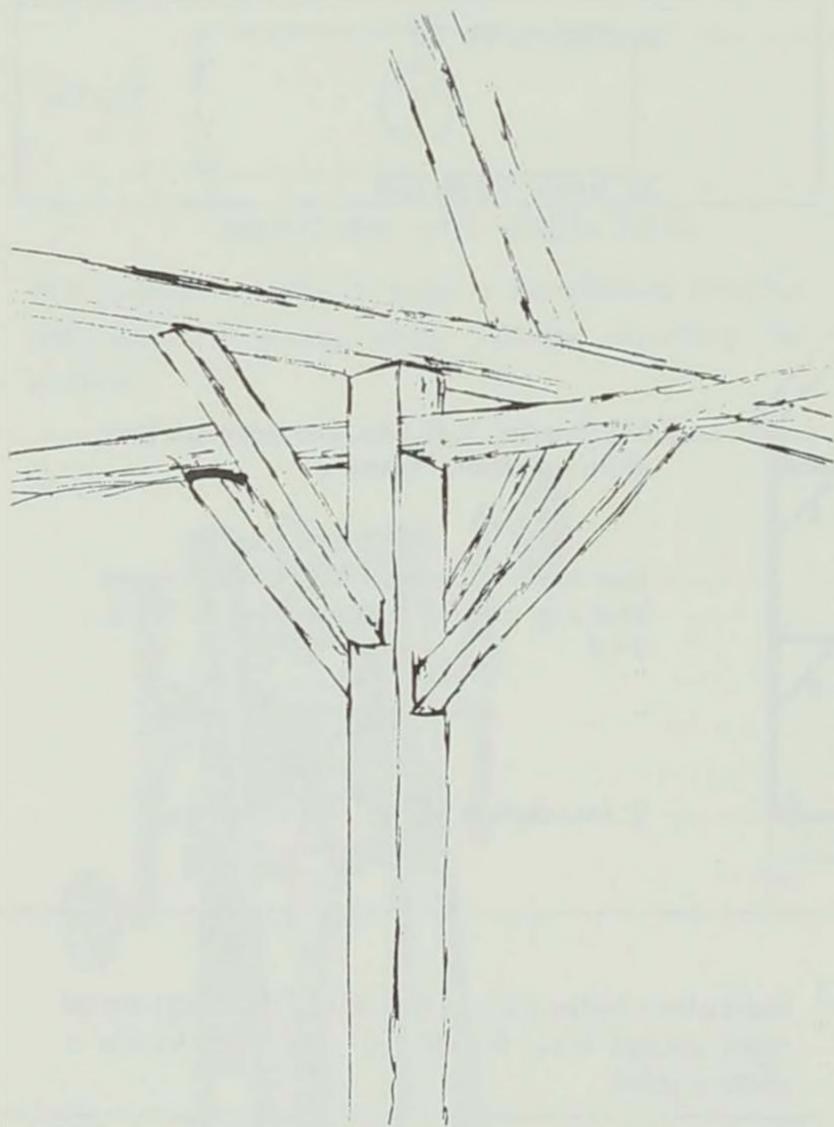
Sketch of the northwest pier in the hay mow showing how the main frame and cross frame meet. (sketch courtesy the author)

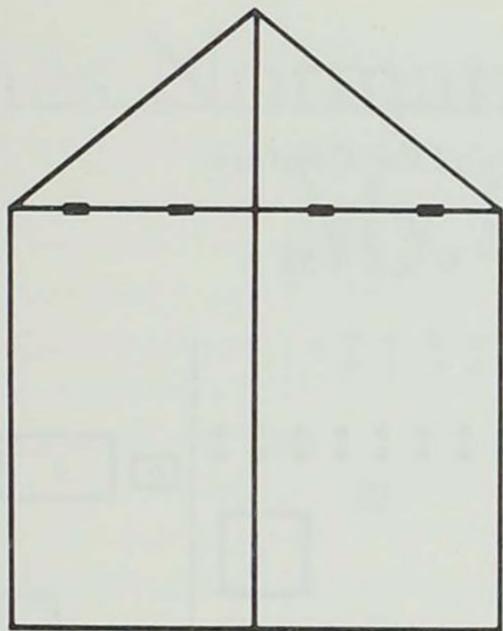
The hay door at the top of the south wall. The hinged top sections drop down, then the big doors open out. An inside platform makes opening and closing the doors easy. (design courtesy the author)

The siding used was 1" x 12" stock boards which stood flush on the concrete foundation and were notched at the top to fit tightly under the roof rafters. The doors were cut as the boards went up and finished later. On the south end were the big barn doors for the hay mow. The hay door at the top of the south wall had a hinged top section which was dropped down before the big doors opened out. A substantial platform, ladder, and two windows on the south end made the hay mow doors very easy to use. A bar inside across the doors held them steady when closed. There was a small platform and ladder inside on the north end to permit window access.

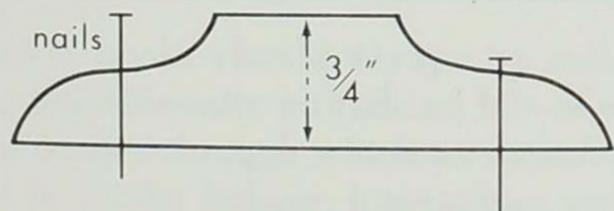
An end view of a batten to cover cracks between stock board siding. (design courtesy the author)

The barn surface was painted. Battens to cover each vertical between the boards were

cut and all surfaces painted. They were then nailed into place and a second coat of paint was applied to seal the entire wood surface.

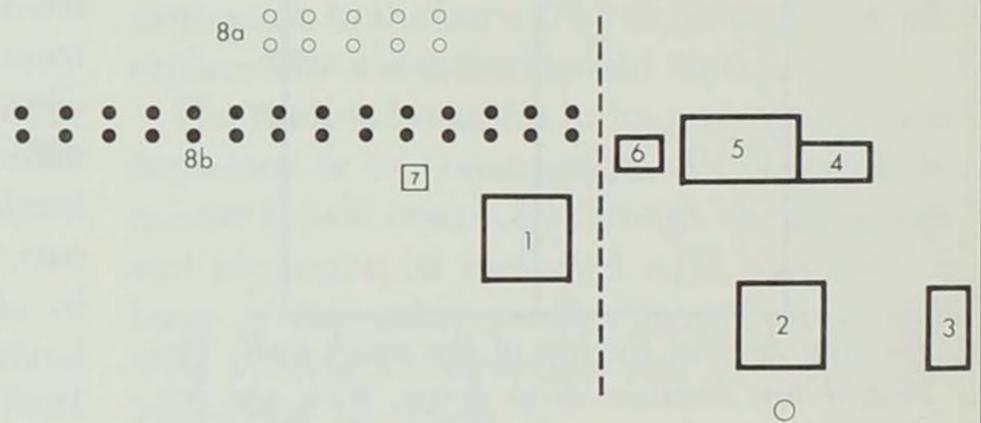
Before 1902

- 1 Old house
- 2 Old barn
- 3 Small pig house
- 4 Chicken house
- 5 Blacksmith shop
- 6 Oat bin
- 7 Outhouse
- 8 Trees: a) fruit b) windbreak
- 0 Well

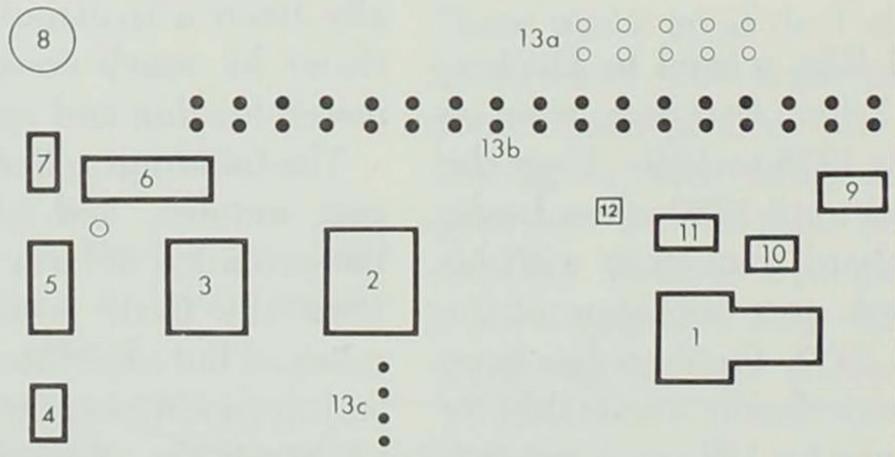
From 1913 to 1950

- 1 House
- 2 Barn
- 3 Corn crib
- 4 Blacksmith/tool shed
- 5 Machine shed
- 6 Hog house
- 7 Boxcar grain storage
- 8 Large tank/wire pile
- 9 Chicken house
- 10 Wash house
- 11 Cob house
- 12 Outhouse
- 13 Trees: a) orchard b) maple windbreak c) willows, short-lived
- 0 Well

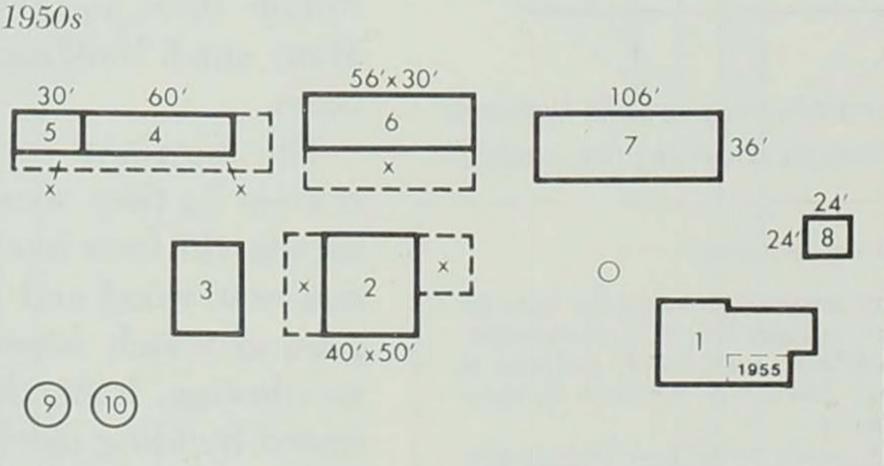
- 1 House (1902), remodeled in 1950s
- 2 Barn (1913)
- 3 Corn crib (1913)
- 4 Old hog house (pre-1950)
- 5 Hog house addition (1955)
- 6 Open hog house (1971)
- 7 Machine building (1969)
- 8 Double garage (1980)
- 9 Drying bin (1973)
- 10 Storage bin (1977)
- 0 Well
- x Automatic waterers
- indicates cement floors

The buildings reflect the same changes. The size, number, and types of buildings explain the evolution of farm life and operation. After 1950 the basic house, built in 1902, was retained but a basement was dug, a gas furnace and air conditioning were added, the porch was enclosed, the chimneys removed, water was piped in, two bathrooms were added, a new kitchen and all new windows were installed, the upstairs got hardwood floors, and the house was re-sided. A large machine building, open hog house, hog house extension, drying and storage bins, and double garage were added. Many small buildings were removed over the years.
